the **play inspection** company

Annual Inspection

Kimble Parish Council

Kimble Green Play Area

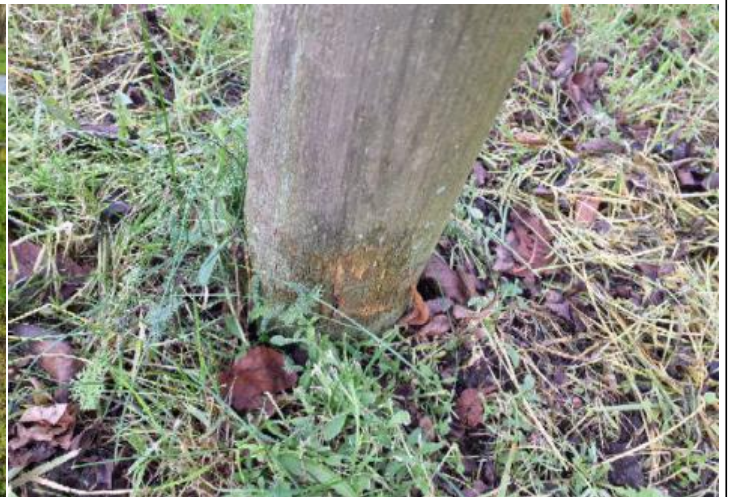
Item: Ancillary Items - Sign
Manufacturer: Not Identified

Finding: There is some strimmer / machinery damage apparent on the posts, this can penetrate the preservative applied to the timber and accelerate the rotting process

Action: Monitor for any deterioration (rot) and replace as required

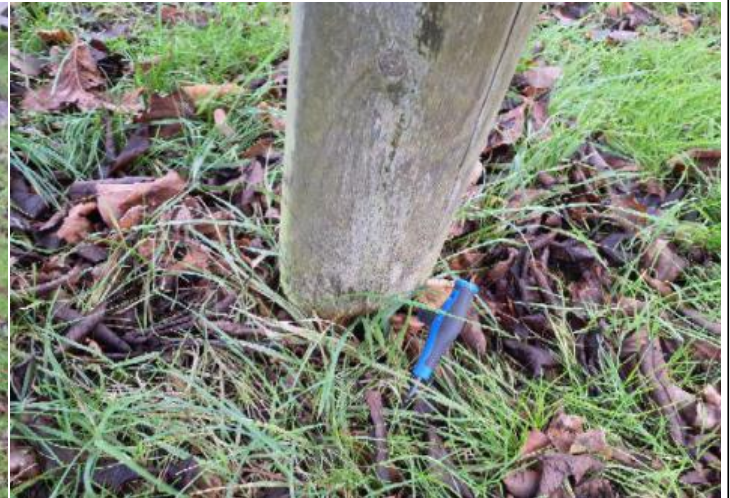
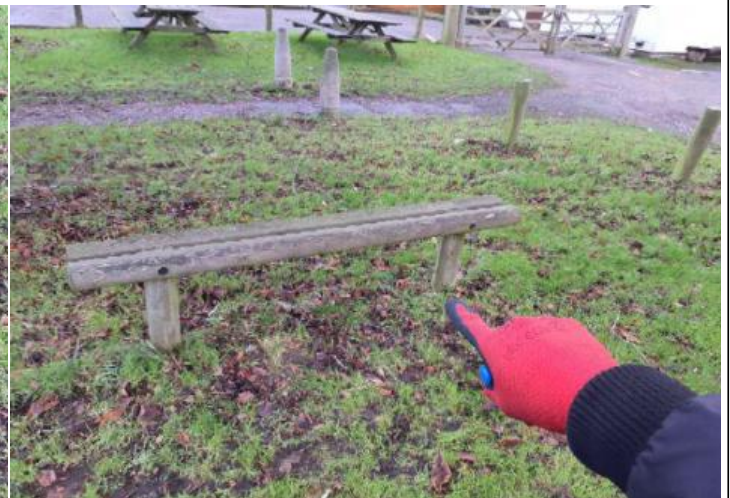
Item: Ancillary Items - Bench
Manufacturer: Not Identified

Finding: There are areas or parts of the timber on the structure that have rotted

Action: Replace all affected timbers

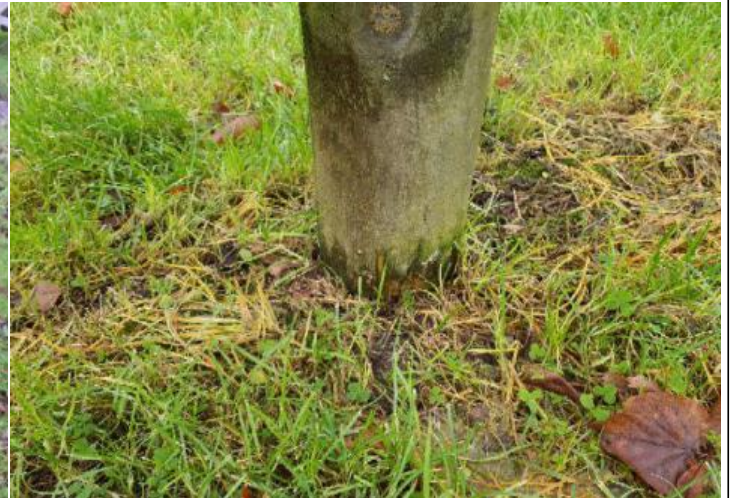
Item: Ancillary Items - Bench
Manufacturer: Not Identified

Finding: There is some strimmer / machinery damage apparent on the posts, this can penetrate the preservative applied to the timber and accelerate the rotting process

Action: Monitor for any deterioration (rot) and replace as required

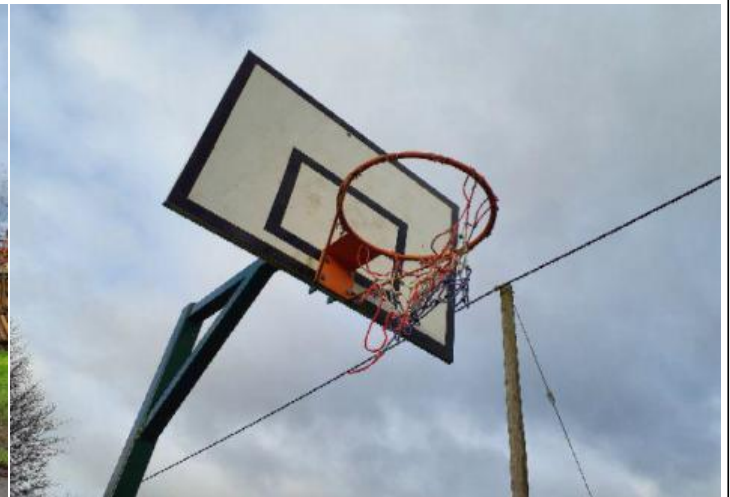
Item: Multi Use Games Area - Basketball Post
Manufacturer: Harrod

Finding: The net is damaged and requires removal / replacement

Action: Replace

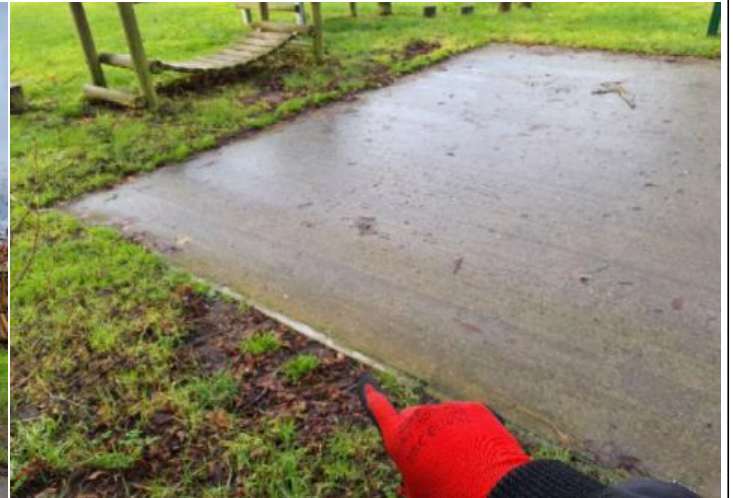
Item: Multi Use Games Area - Basketball Post
Manufacturer: Harrod

Finding: There are trip hazards at the edges of the surface **Action:** Remove trip hazard

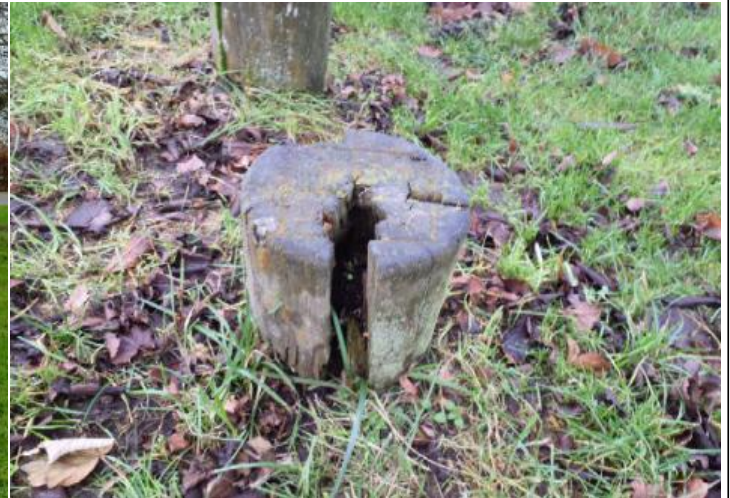
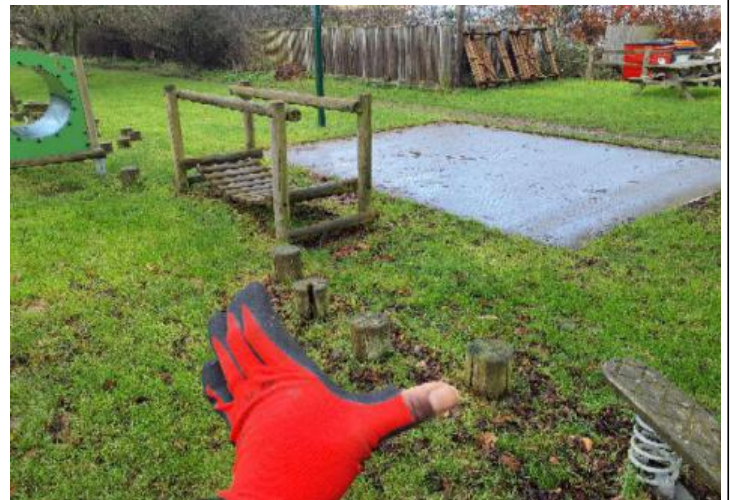
Item: Activity Equipment - Activity Trail
Manufacturer: Playdale Playgrounds Ltd

Finding: There are areas or parts of the timber on the structure that have rotted

Action: Replace all affected timbers

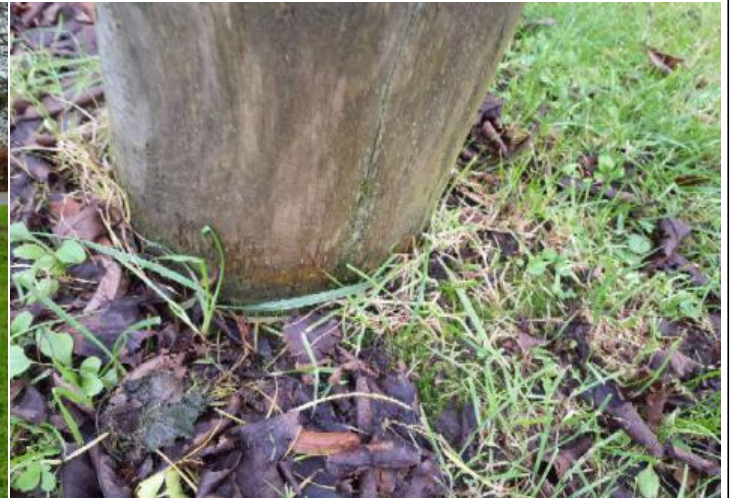
Item: Activity Equipment - Activity Trail
Manufacturer: Playdale Playgrounds Ltd

Finding: There is some strimmer / machinery damage apparent on the posts, this can penetrate the preservative applied to the timber and accelerate the rotting process

Action: Monitor for any deterioration (rot) and replace as required

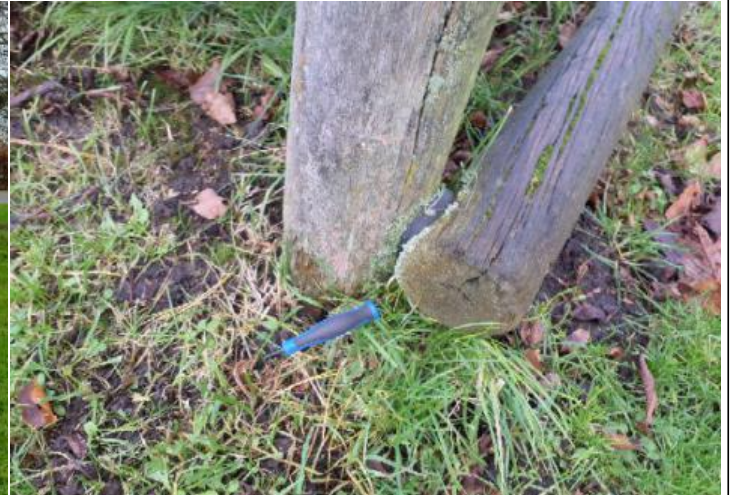
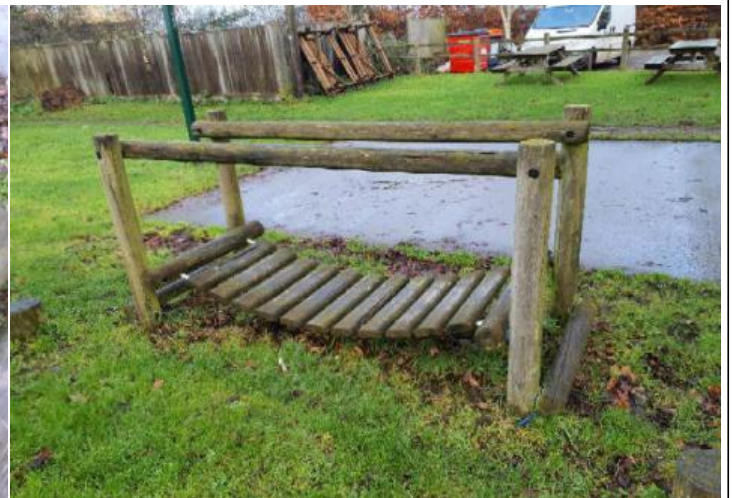
Item: Activity Equipment - Activity Trail
Manufacturer: Playdale Playgrounds Ltd

Finding: There are areas or parts of the timber on the bridge that have rotted

Action: Replace all affected timbers

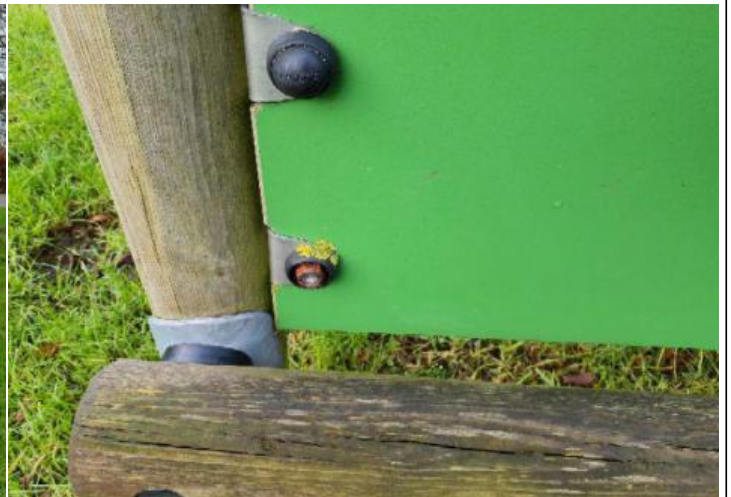
Item: Activity Equipment - Activity Trail
Manufacturer: Playdale Playgrounds Ltd

Finding: There is/are bolt cap covers missing or damaged on the item

Action: Replace missing or damaged bolt cap covers

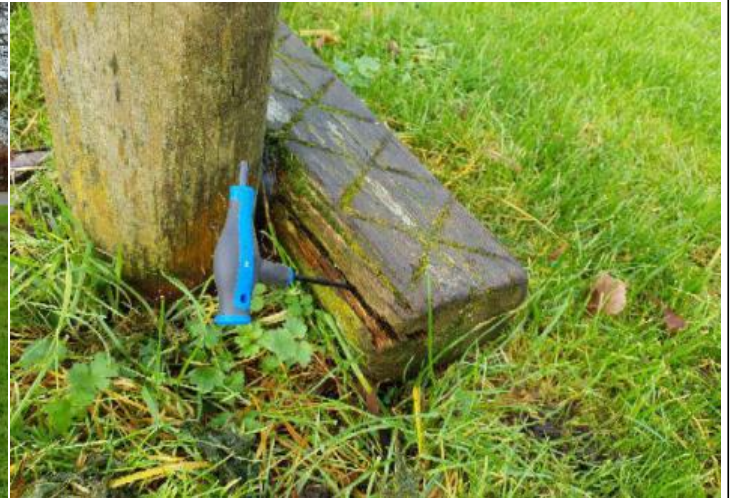
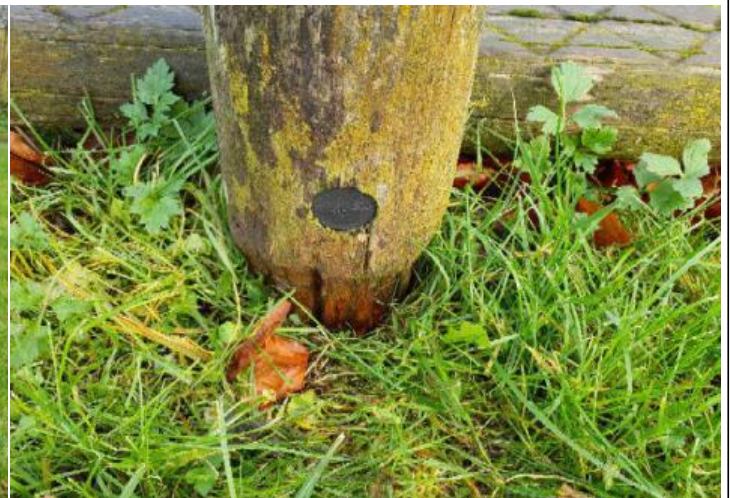
Finding: There are areas or parts of the timber on the log weave that have rotted

Action: Replace all affected timbers

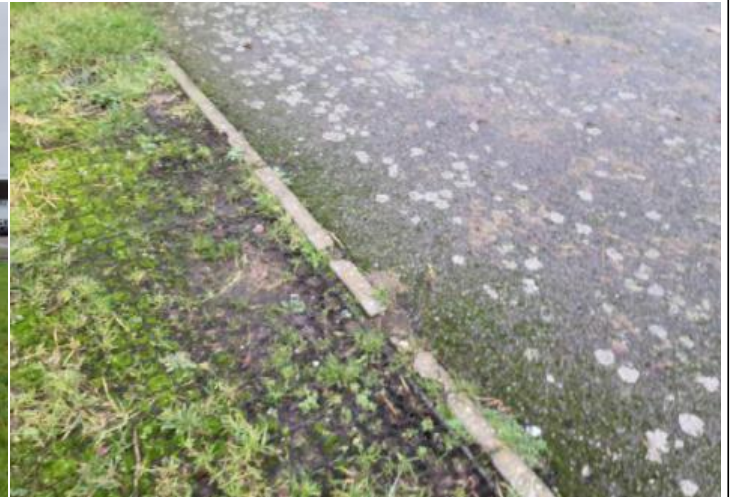
Finding: There are trip hazards at the edges of the surface

Action: Remove trip hazard

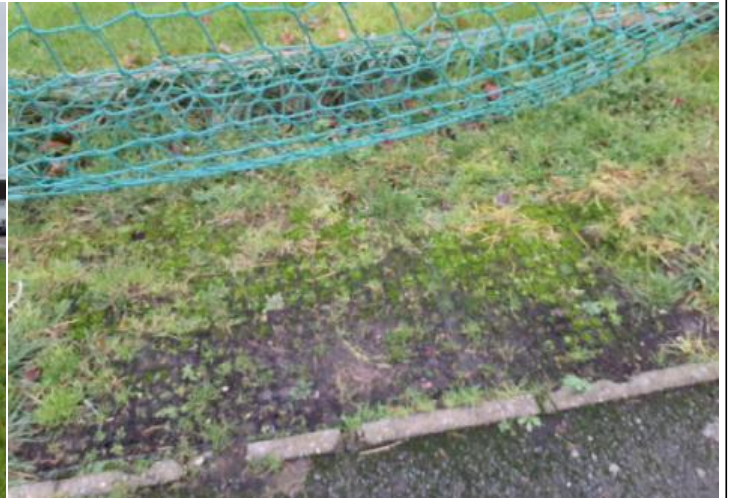
Finding: There is algae, silt or moss growth on the surface resulting in slippery conditions

Action: Clean and treat appropriately

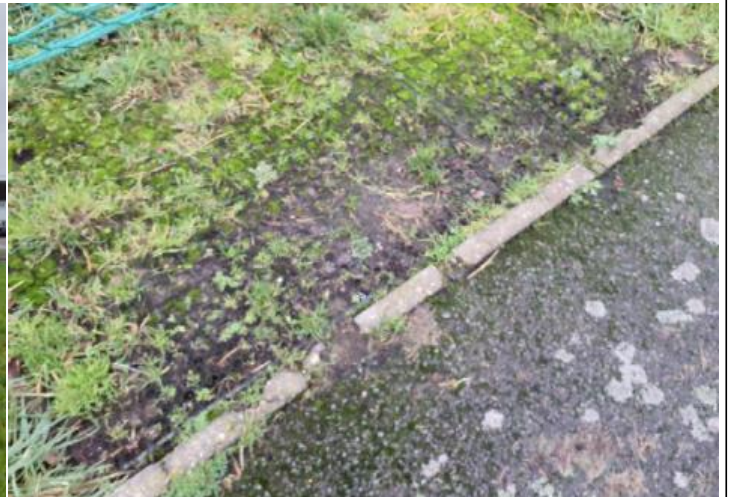
Finding: The concrete edging is damaged

Action: Monitor for any further deterioration and repair or replace as required

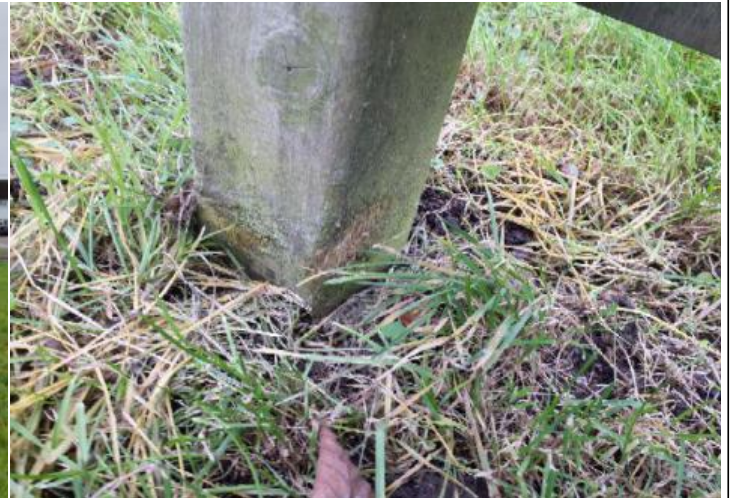
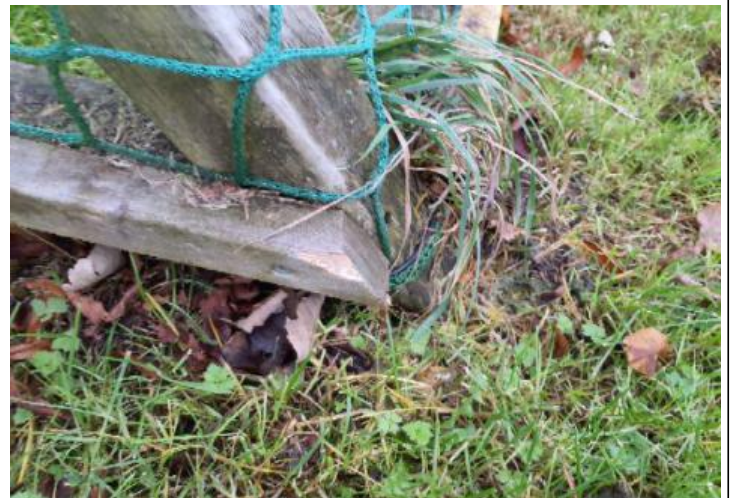
Finding: There is some strimmer / machinery damage apparent on the posts, this can penetrate the preservative applied to the timber and accelerate the rotting process

Action: Monitor for any deterioration (rot) and replace as required

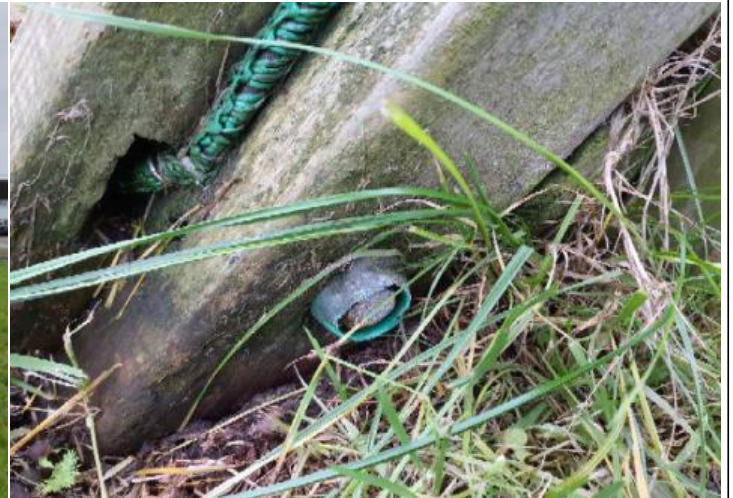
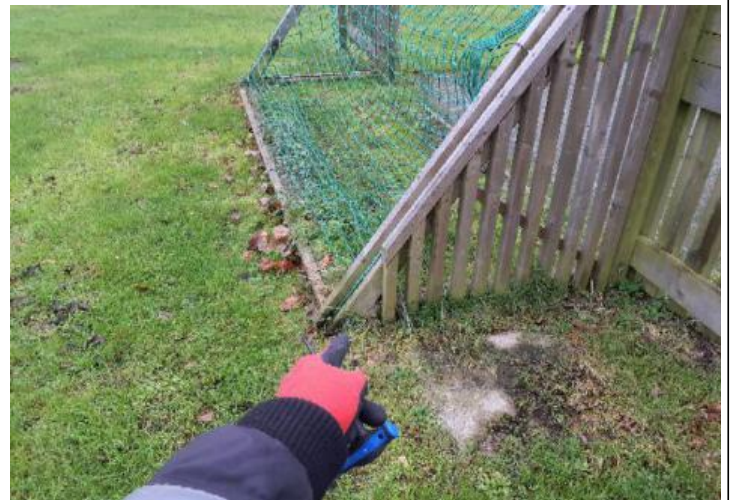
Finding: There is/are bolt cap covers missing or damaged on the item

Action: Replace missing or damaged bolt cap covers

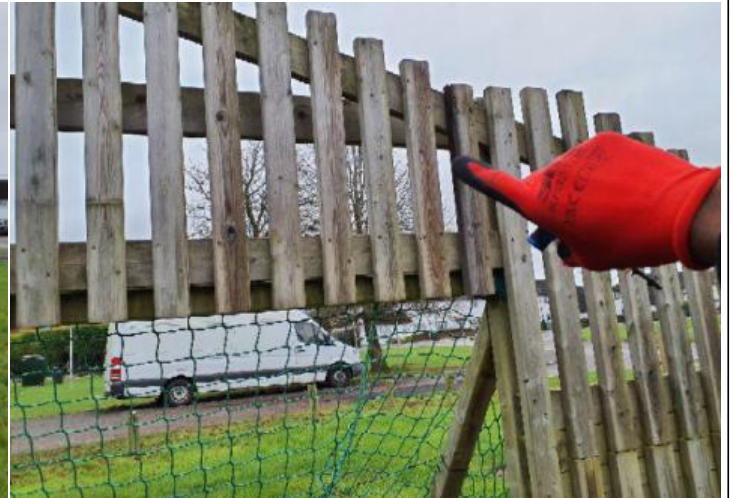
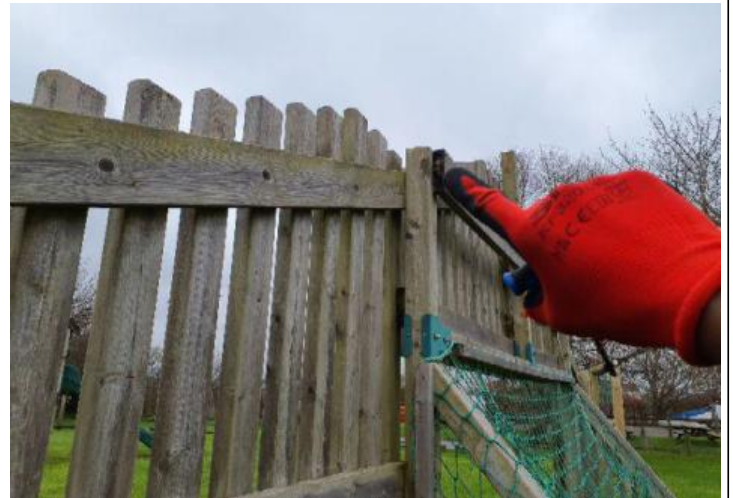
Finding: There are areas or parts of the timber on the structure that have rotted

Action: Replace all affected timbers

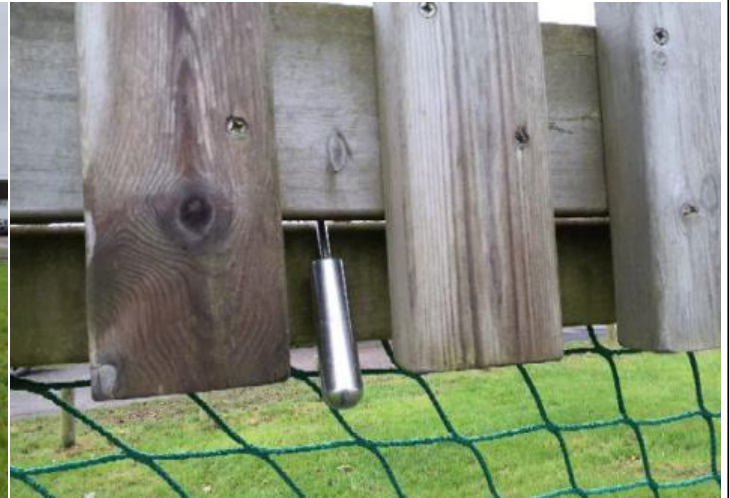
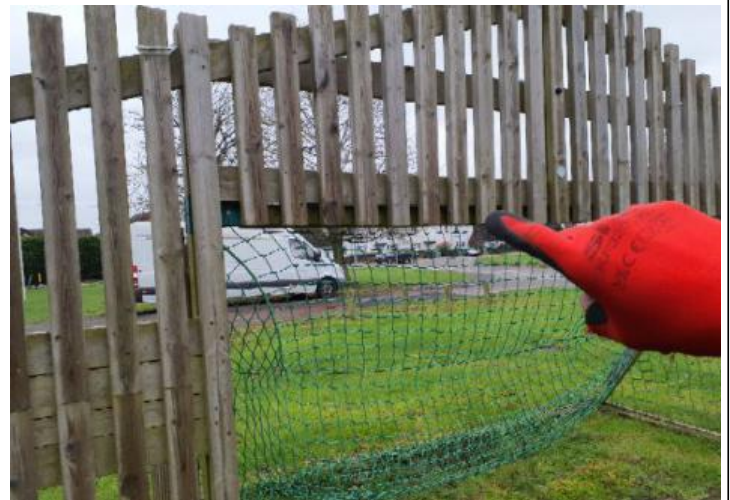
Finding: There is/are finger entrapments in the goal frame and the item fails to meet the requirements of BS EN 15312 Clause 4.4.2.2 Entrapment of fingers

Action: Monitor - No action given the risk assessment

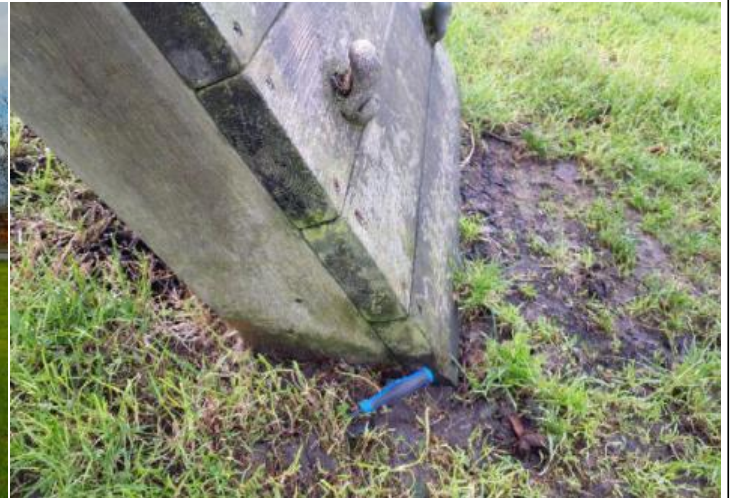
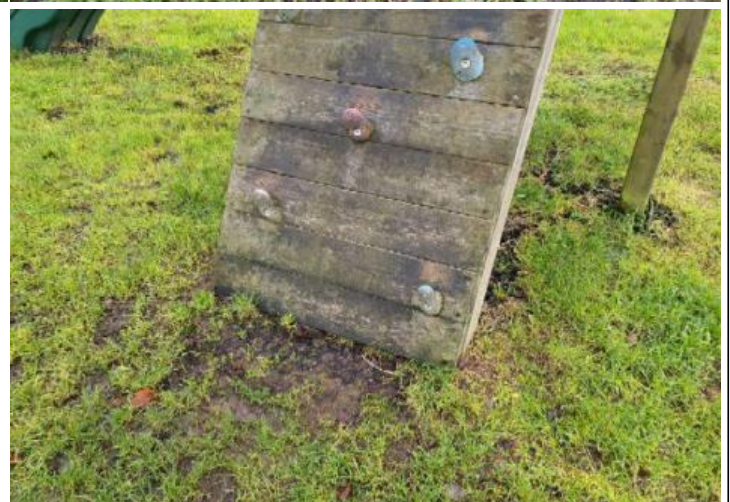
Finding: There is some evidence of rot in the timber

Action: Monitor for any further deterioration and replace as required

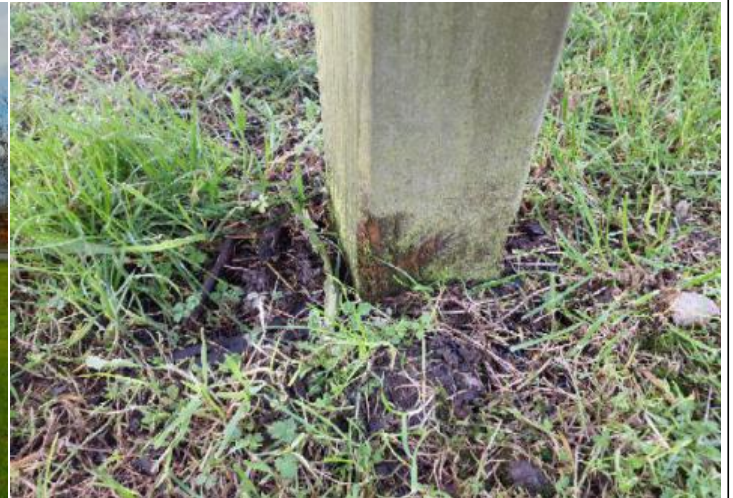
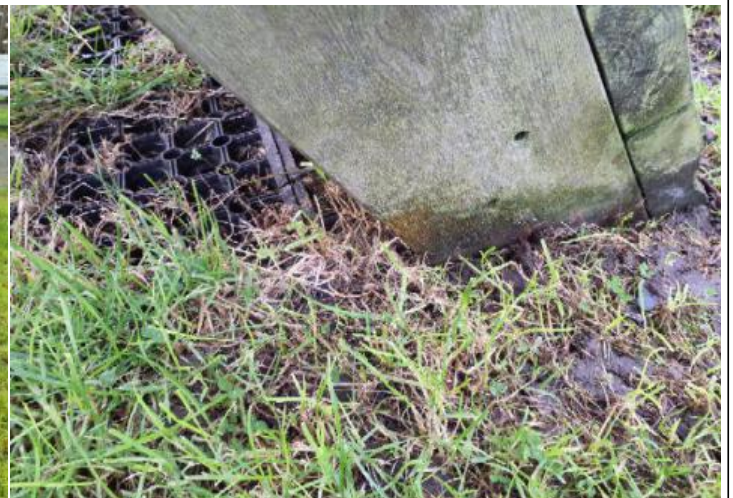
Finding: There is some strimmer / machinery damage apparent on the posts, this can penetrate the preservative applied to the timber and accelerate the rotting process

Action: Monitor for any deterioration (rot) and replace as required

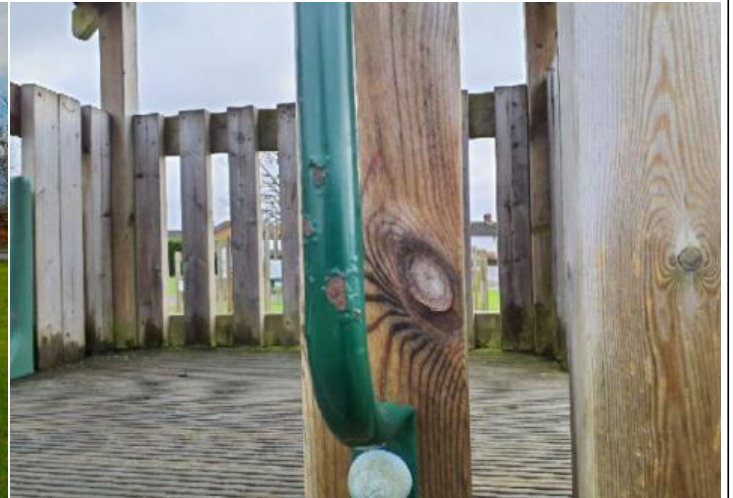
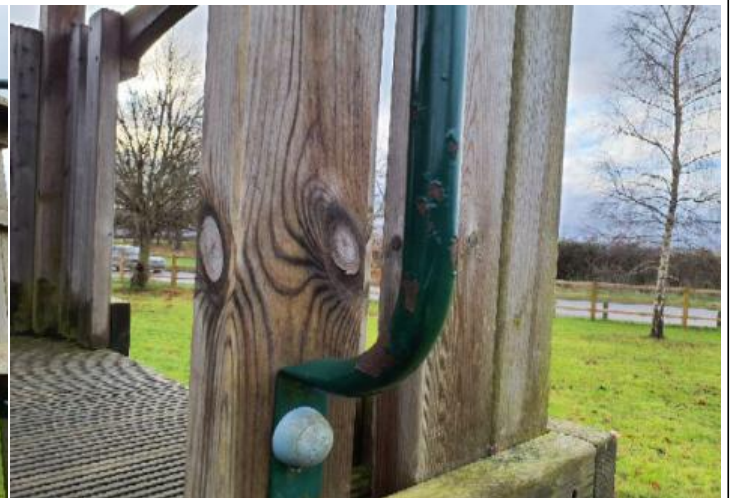
Finding: The paintwork on this item has been damaged or worn exposing the metal underneath which is rusting / corroding

Action: Treat affected areas and repaint

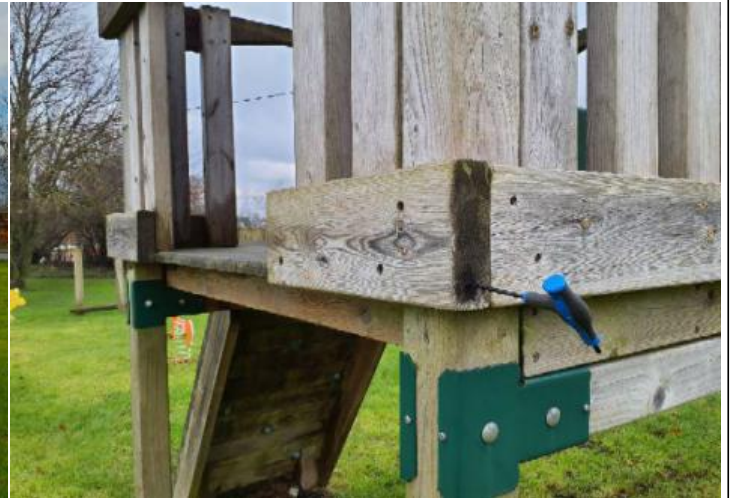
Finding: There is some evidence of rot in the timber

Action: Monitor for any further deterioration and replace as required

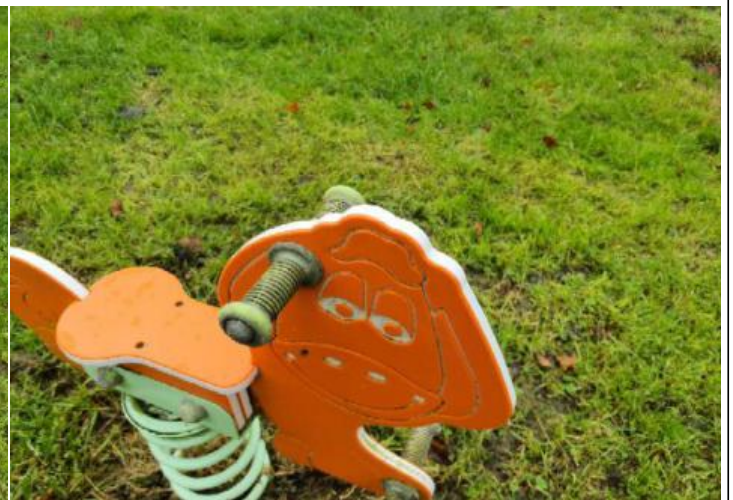
Finding: The Handgrips/Footrests rotate and may cause an unexpected movement for the user

Action: Secure Handgrips/Footrests to prevent rotation.

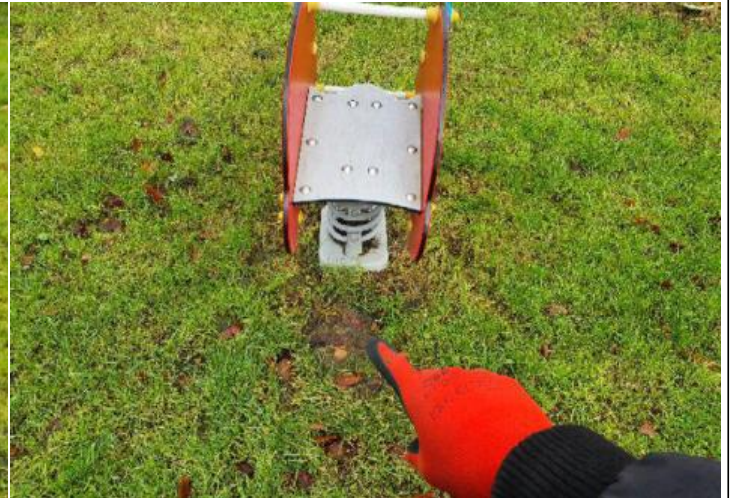
Finding: The surface has eroded in some areas and may be slippery in wet conditions
Action: Reinstate the surface

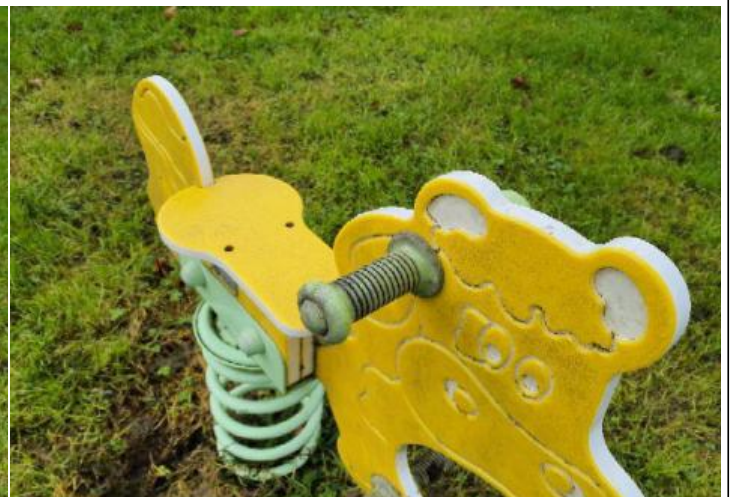
Finding: The Handgrips/Footrests rotate and may cause an unexpected movement for the user
Action: Secure Handgrips/Footrests to prevent rotation.

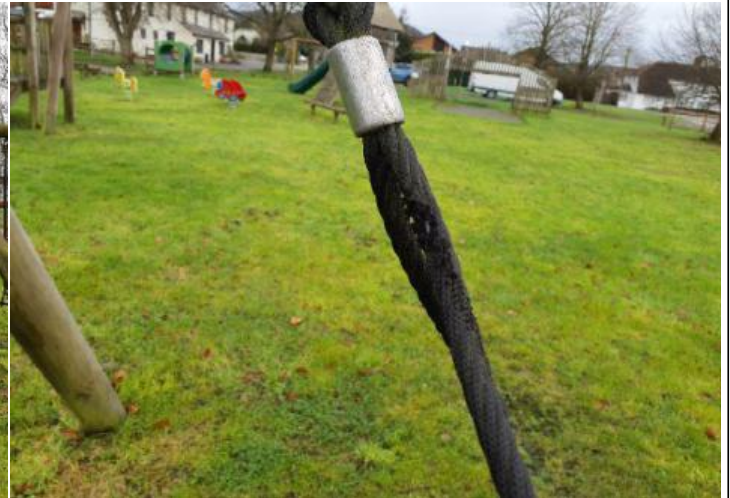
Finding: The ropes/nets are worn/damaged in places

Action: Monitor for any further deterioration and repair or replace as required

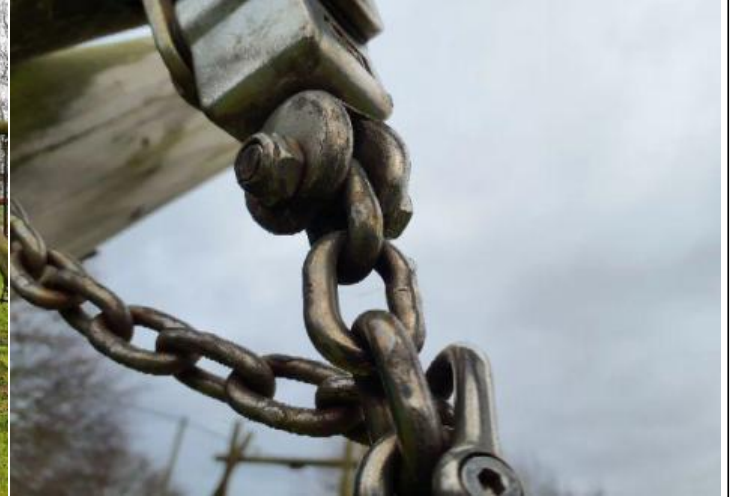
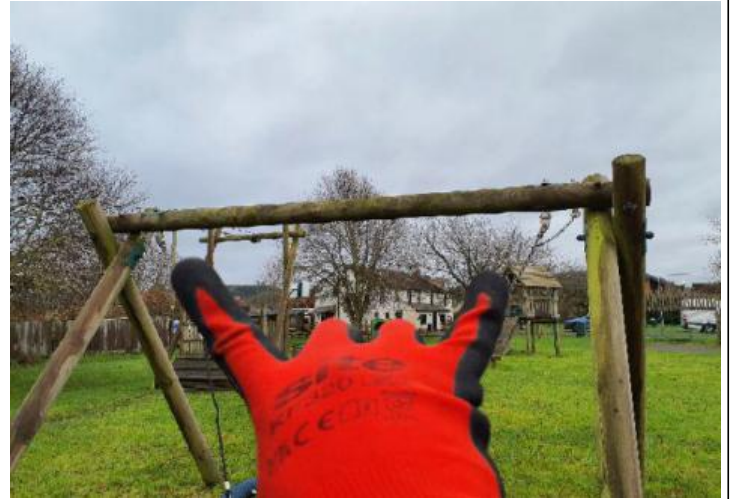
Finding: There is some notable evidence of chain wear

Action: Monitor for any further deterioration and replace when 40% worn

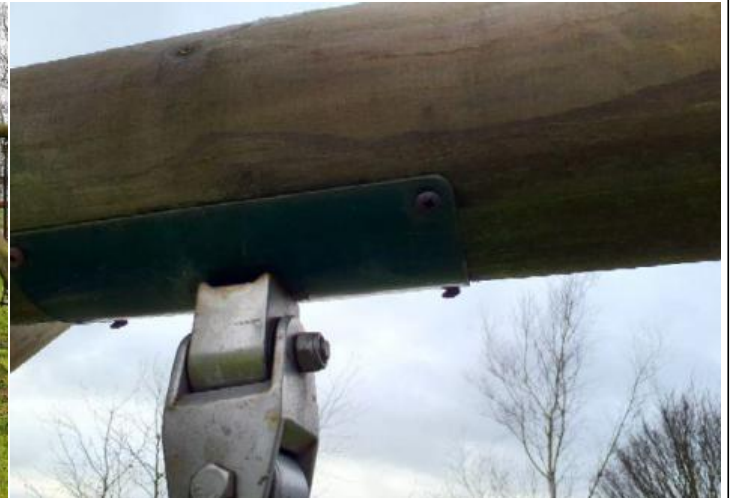
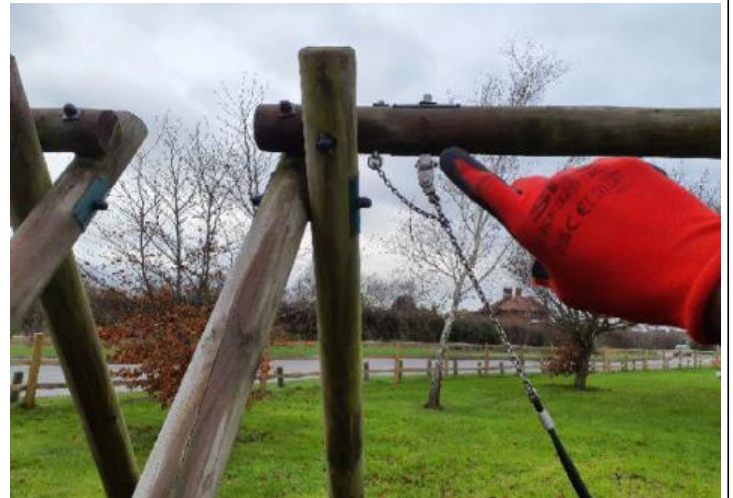
Finding: A number of fixing(s) have worked loose on the suspension brackets

Action: Secure all loose fixings

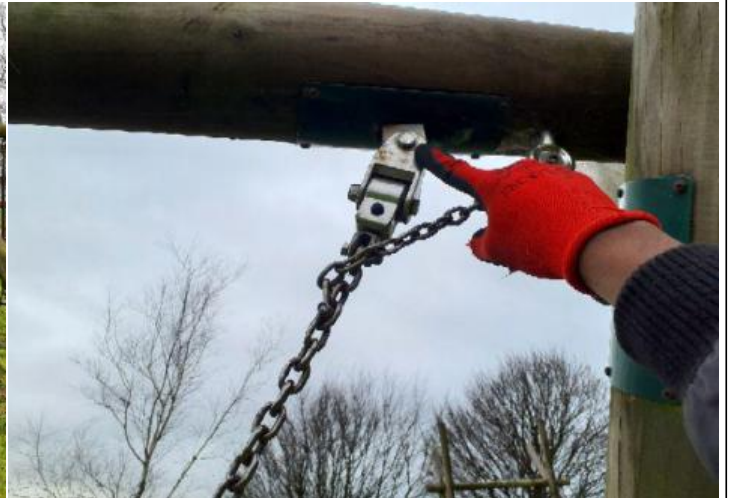
Finding: The bush / bushes is / are showing signs of wear

Action: Monitor for any further deterioration and replace as required

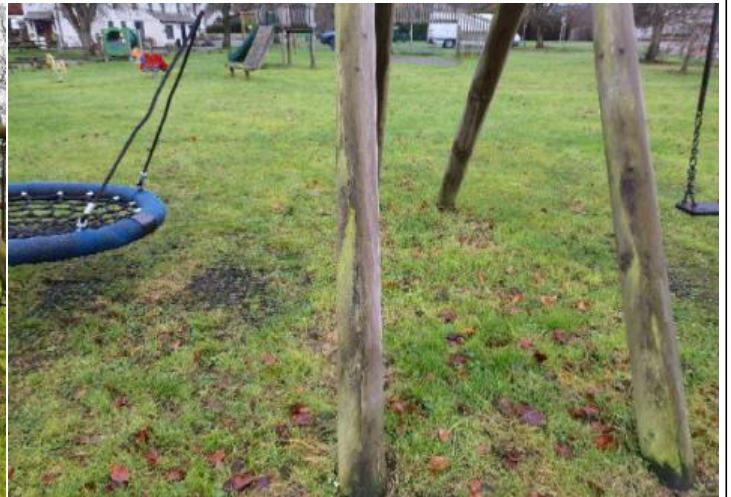
Finding: The timber has a number of splits/shakes or air cracks and this may affect the stability or allow water ingress which will accelerate the rotting process

Action: Monitor to ensure the splits do not cross through fixing points of the structure and/or cause any instability

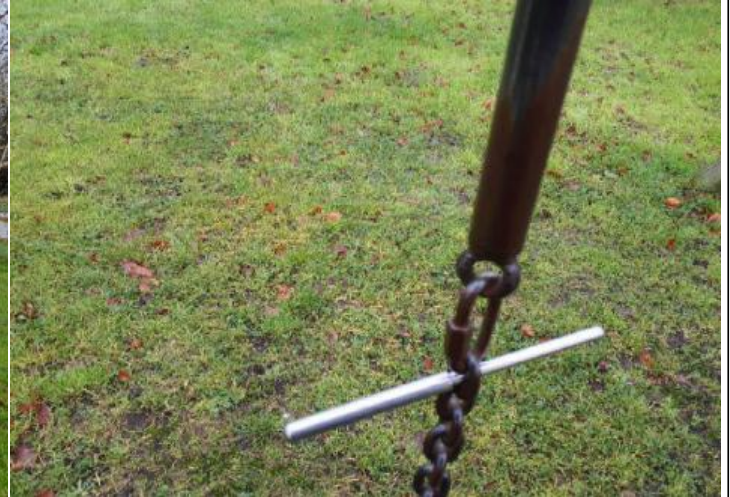
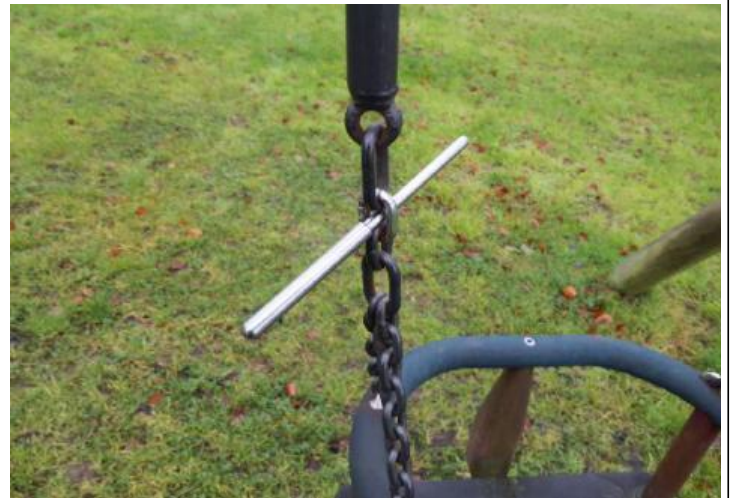
Finding: The chain openings are in excess of the 8.6mm as recommended by BS EN 1176 **Action:** Monitor - No action given the risk assessment

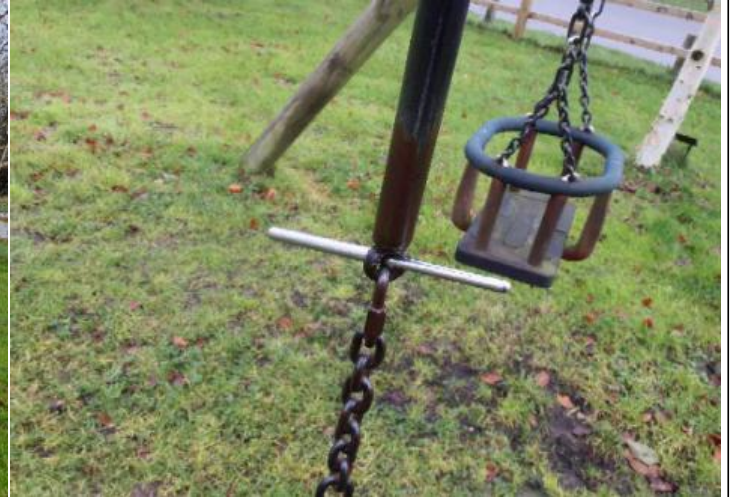
Finding: The connecting links are in excess of 8.6mm and less than 12mm and fail the requirements of BS EN 1176 Part 1; clause 4.2.13, Chains

Action: Monitor - No action given the risk assessment

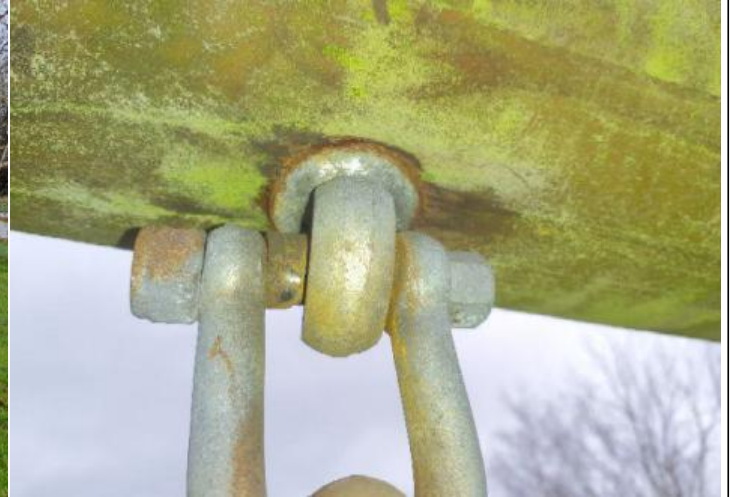
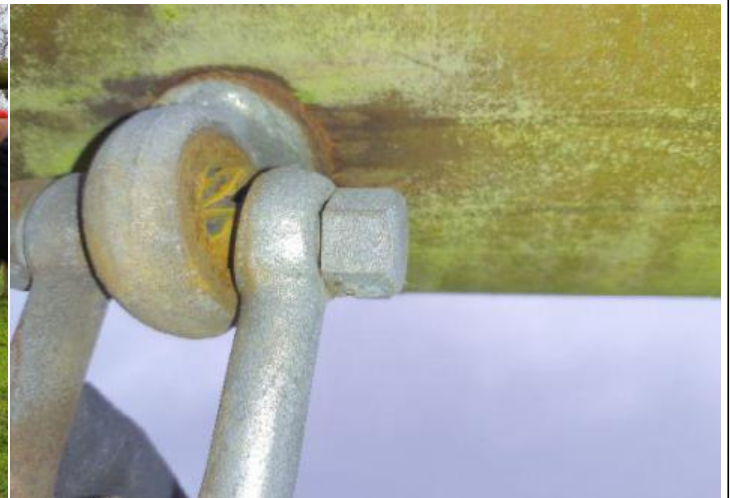
Finding: The bush / bushes is / are worn or missing

Action: Replace worn or missing bushes

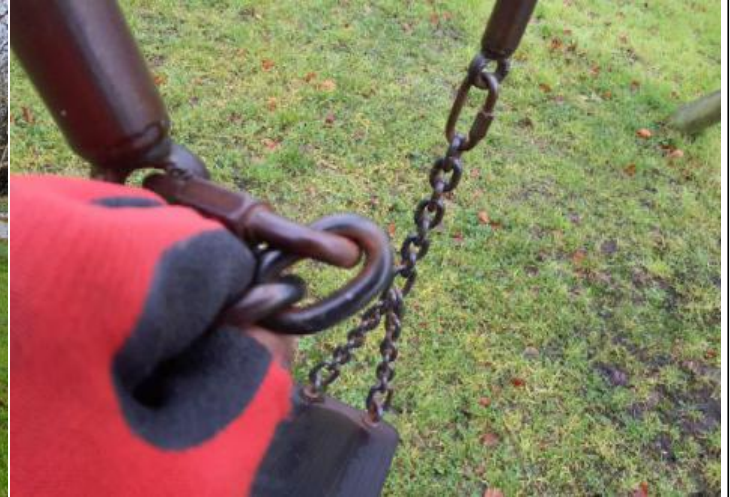
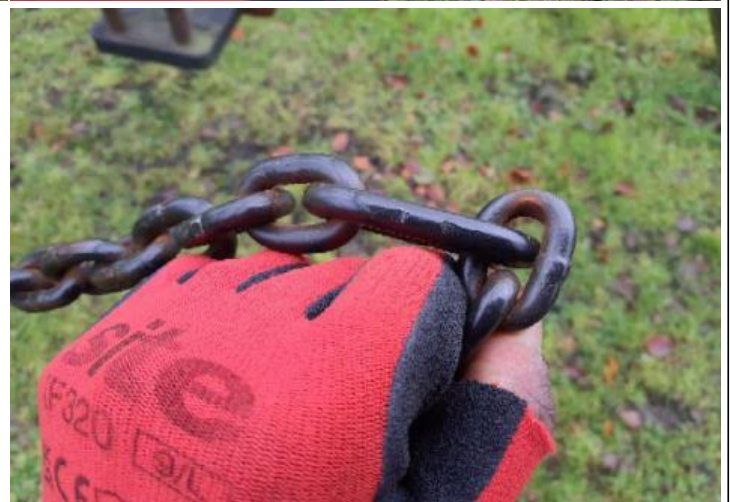
Finding: There is some notable evidence of chain wear

Action: Monitor for any further deterioration and replace when 40% worn

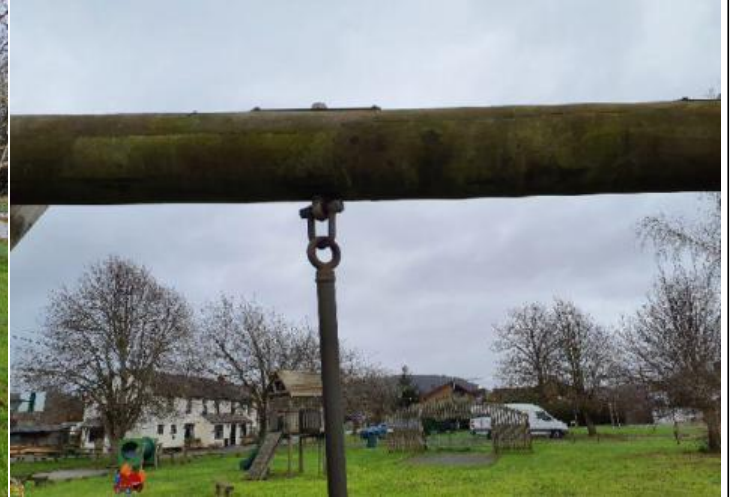
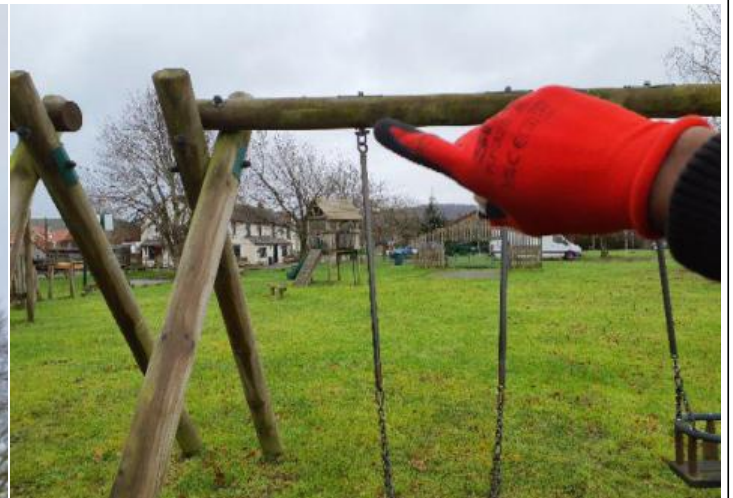
Finding: The suspension member shackle is not aligned correctly with the direction of travel creating accelerated wear

Action: Adjust the alignment of the suspension shackle

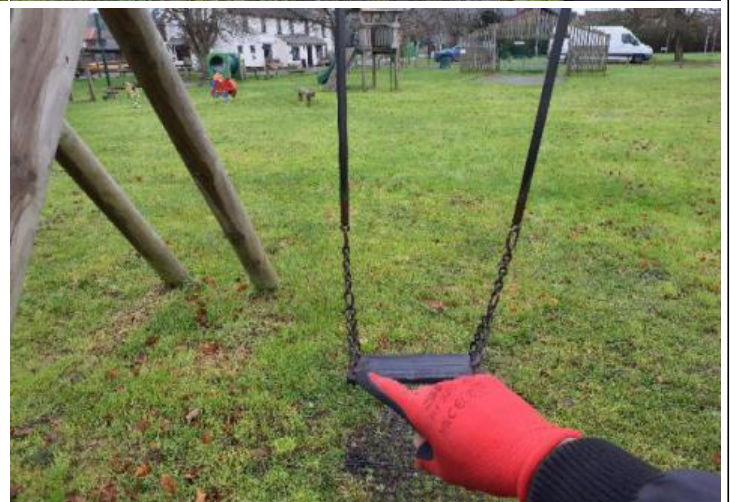
Finding: The swing seat connectors are loose

Action: Tighten to secure

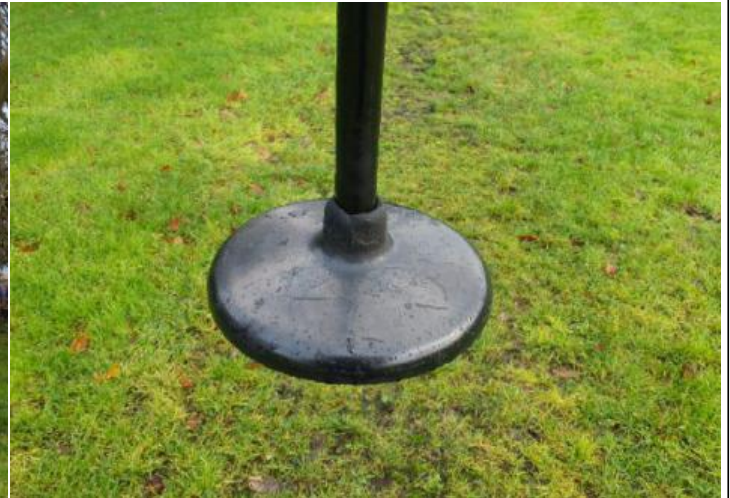
Finding: The seat connection cannot be inspected without dismantling the seat

Action: Dismantle the seat to inspect the seat connection for wear

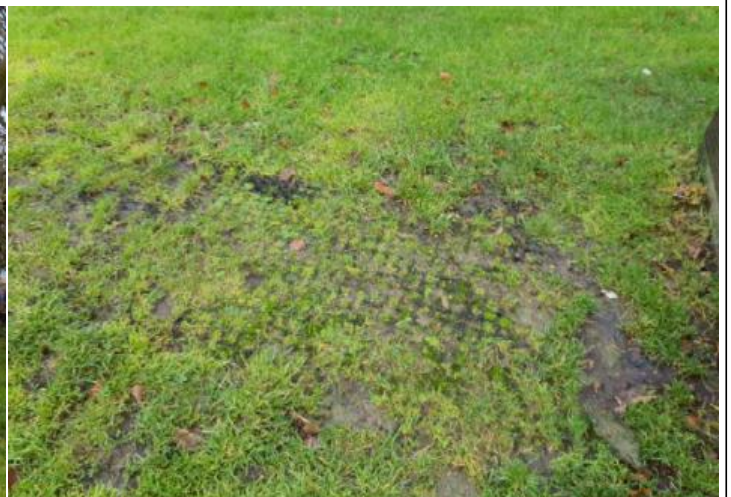
Finding: There is algae, silt or moss growth on the surface resulting in slippery conditions

Action: Clean and treat appropriately

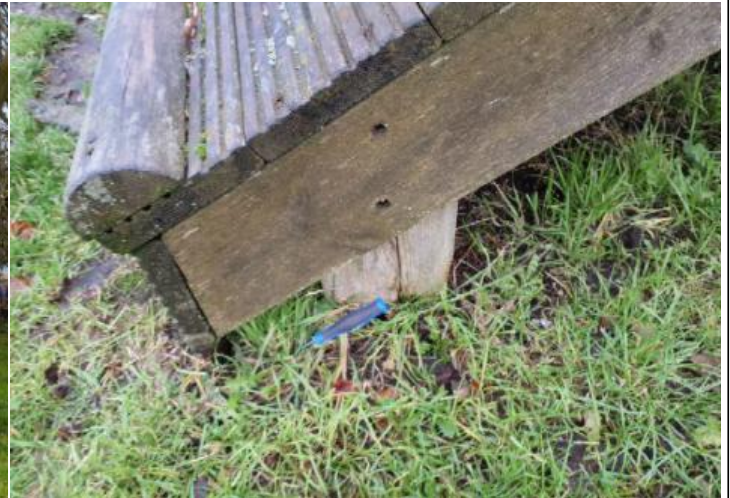
Finding: There is some evidence of rot in the timber

Action: Monitor for any further deterioration and replace as required

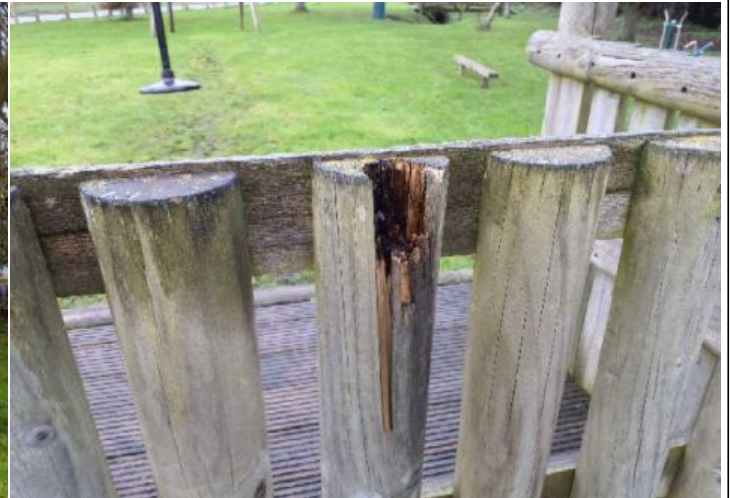
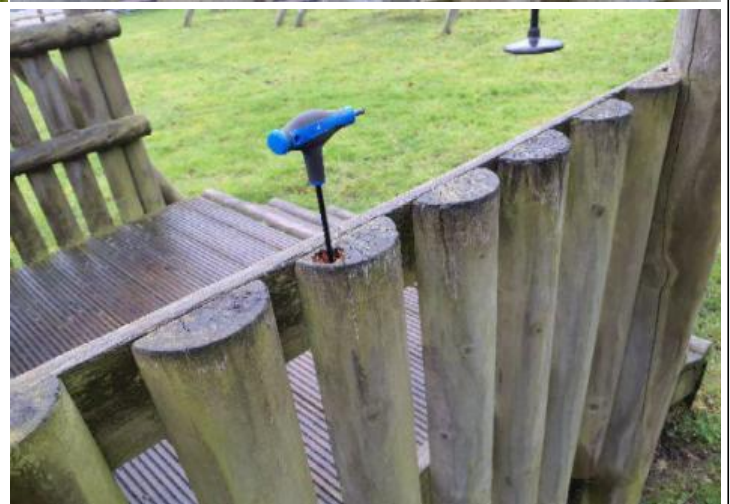
Finding: There are areas or parts of the timber on the structure that have rotted

Action: Replace all affected timbers

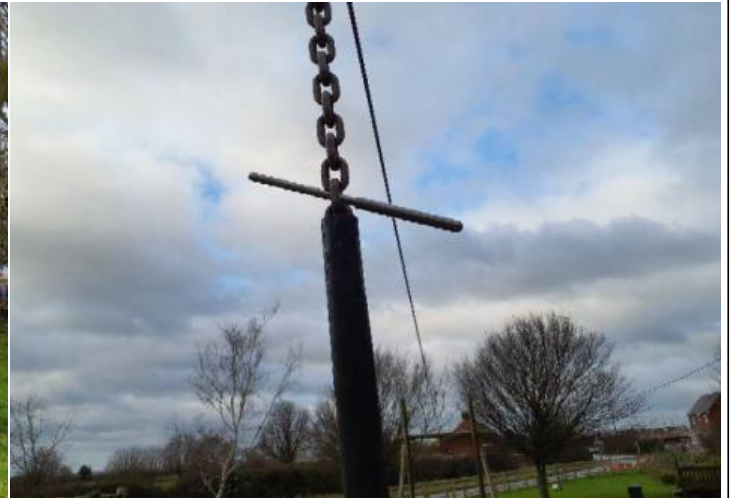
Finding: The chain openings are in excess of 8.6mm and do not meet the recommendations of BS EN 1176 Part 1

Action: Monitor - No action given the risk assessment
