the **play inspection** company

Annual Inspection

Kimble Parish Council

Kimble Green Play Area

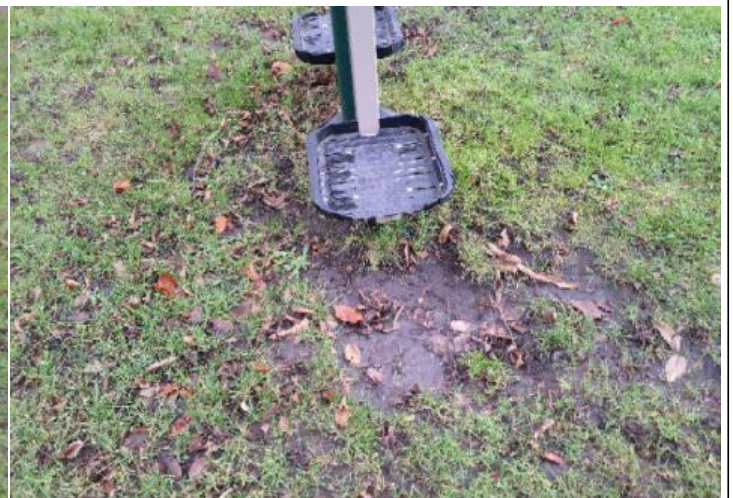
Finding: The surface has eroded in some areas and may be slippery in wet conditions

Action: Reinstate the surface

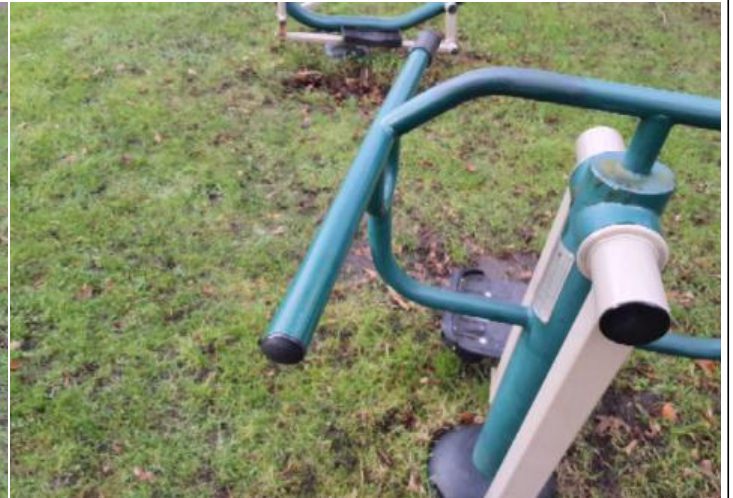
Finding: One or more handgrip(s) are damaged or missing. **Action:** Replace missing or damaged handgrips

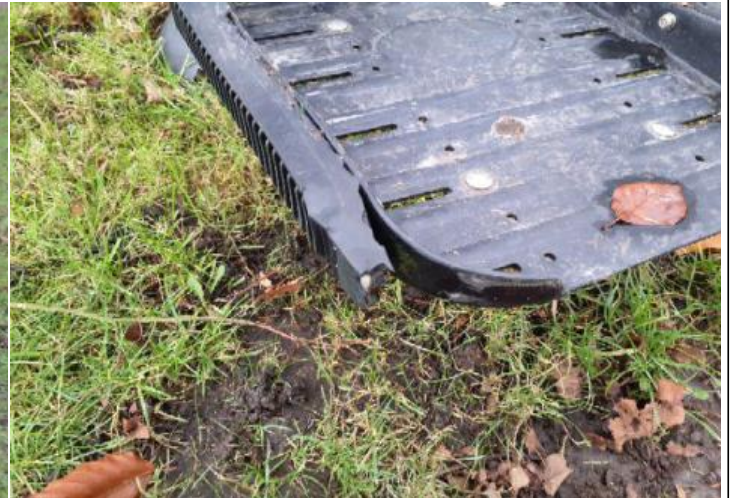
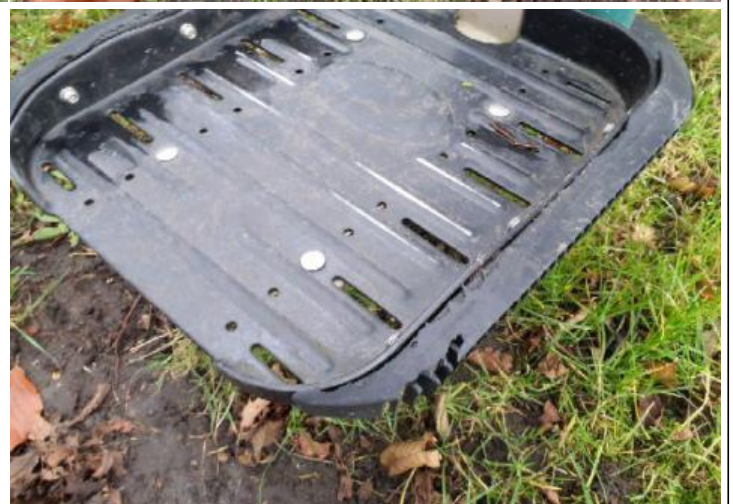
Finding: The buffers are worn

Action: Replace worn buffers

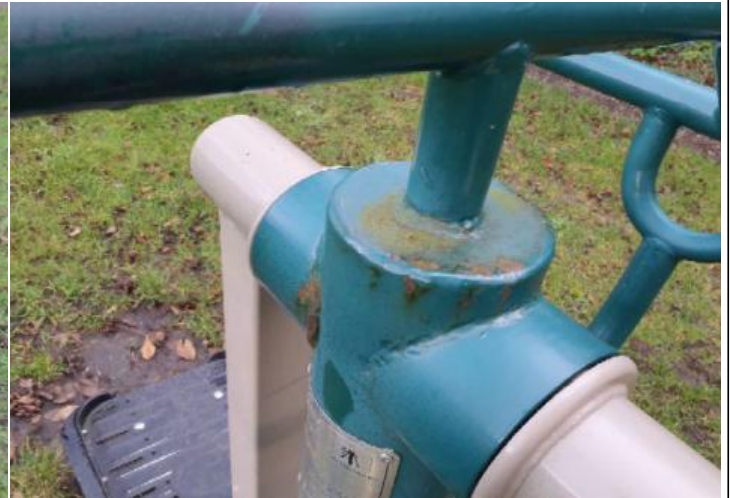
Finding: The paintwork on this item has been damaged or worn exposing the metal underneath which is rusting / corroding

Action: Treat affected areas and repaint

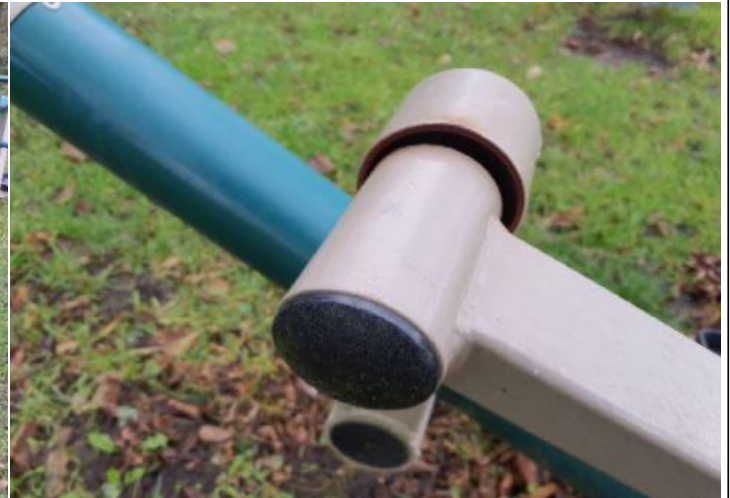
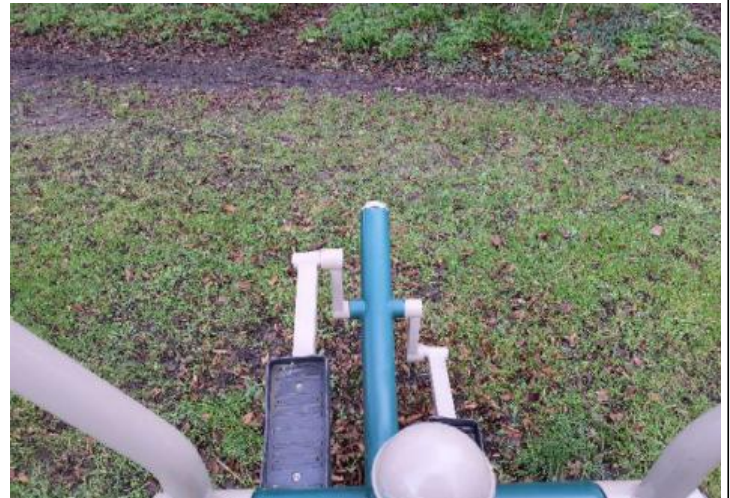
Item: Outdoor Fitness Equipment - Cross Trainer **Risk Level:** L - Low Risk
Manufacturer: Sunshine Gym **Surface:** Grass

Finding: The bearing is worn / damaged and the item is not operating correctly **Action:** Repair / replace

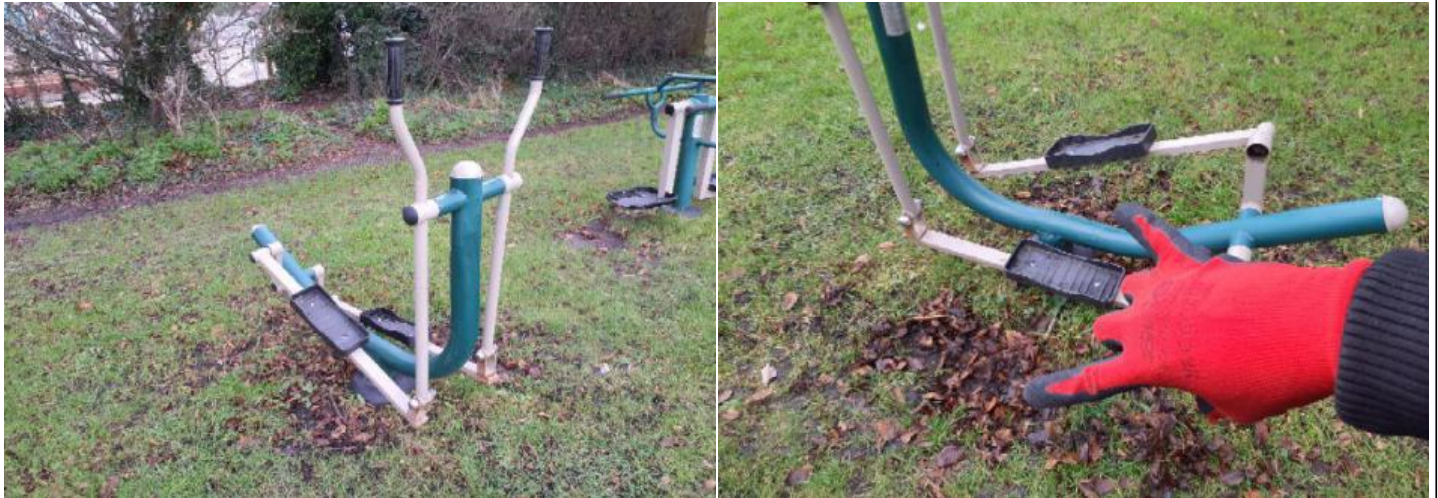
Item: Outdoor Fitness Equipment - Cross Trainer **Risk Level:** L - Low Risk
Manufacturer: Sunshine Gym **Surface:** Grass

Finding: The surface has eroded in some areas and may be slippery in wet conditions **Action:** Reinstate the surface

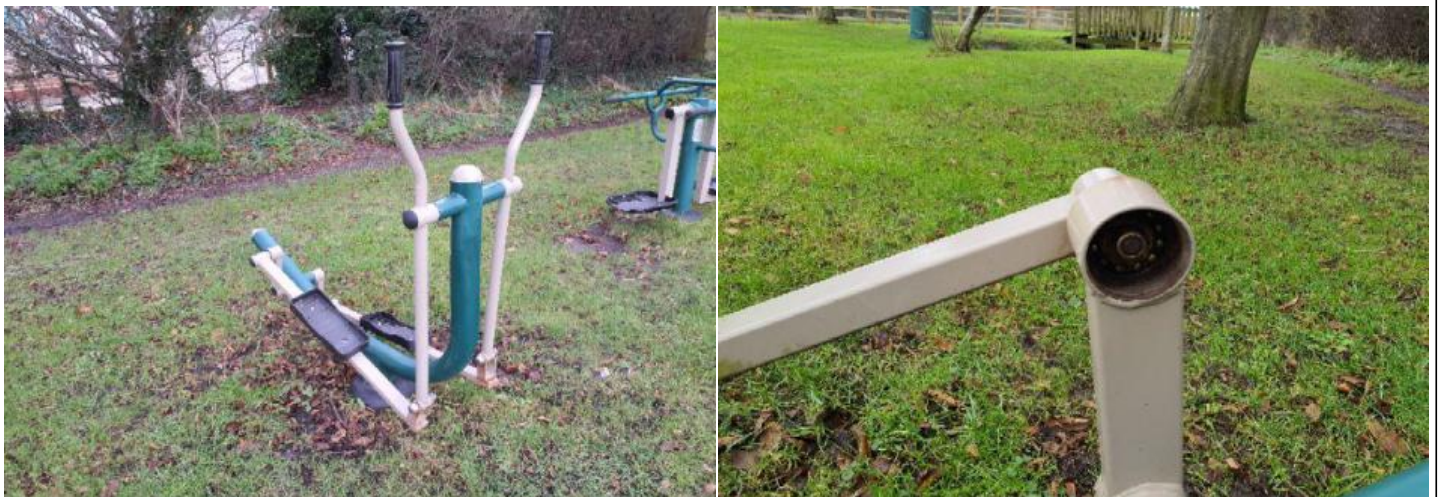
Item: Outdoor Fitness Equipment - Cross Trainer **Risk Level:** L - Low Risk
Manufacturer: Sunshine Gym **Surface:** Grass

Finding: There is / are post or end caps missing / damaged **Action:** Replace missing / damaged post or end caps on the item

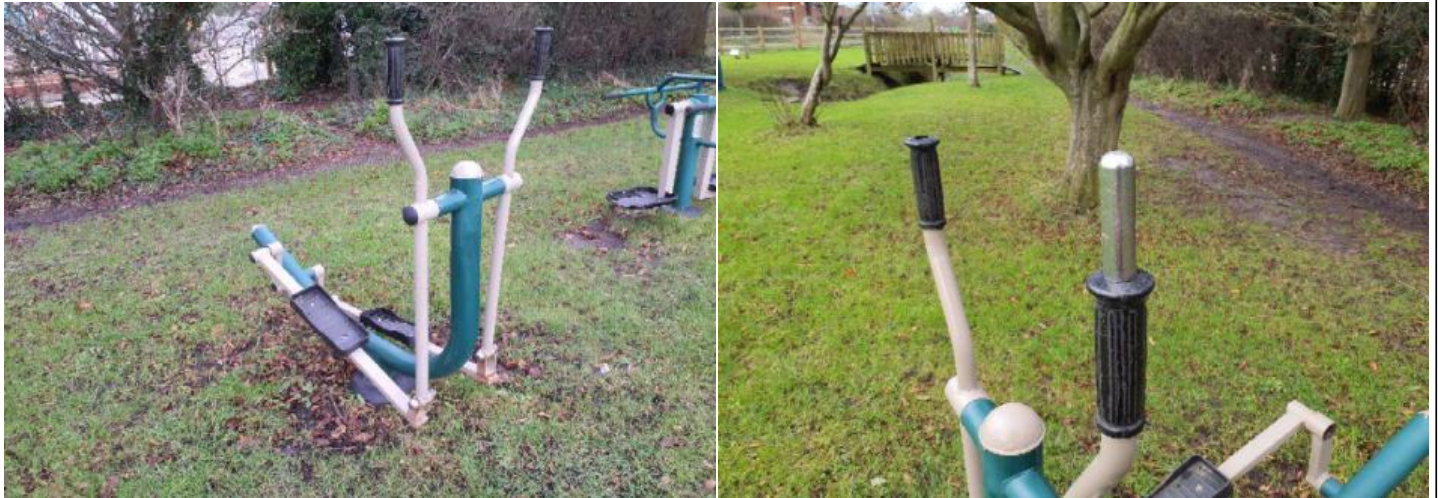
Item: Outdoor Fitness Equipment - Cross Trainer **Risk Level:** V - Very Low Risk
Manufacturer: Sunshine Gym **Surface:** Grass

Finding: There is/are missing inserts creating finger entrapment/s in the handgrips and the item fails to meet the requirements of BS EN 16630:2015 4.3.6.2 Entrapment of fingers

Action: Replace the missing inserts to remove the entrapment from the equipment

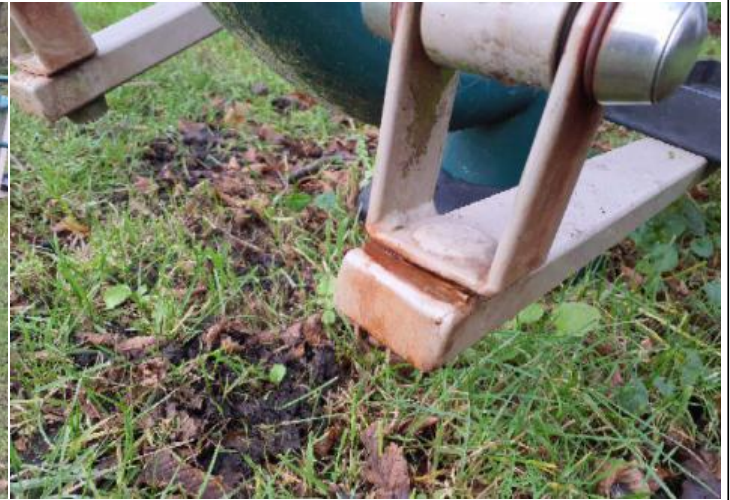
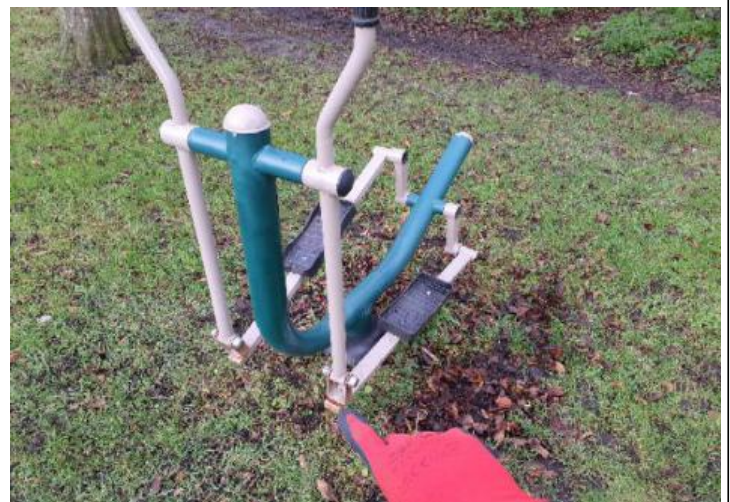
Item: Outdoor Fitness Equipment - Cross Trainer **Risk Level:** L - Low Risk
Manufacturer: Sunshine Gym **Surface:** Grass

Finding: A number of fixing(s) have worked loose

Action: Secure all loose fixings
