the **play inspection** company

Annual Inspection

Kimble Parish Council

Kimble Green Play Area

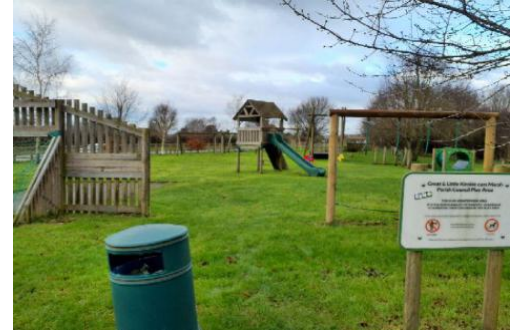
NOTE - There is a body of water or a water basin in close proximity to the playground. Risk assessment of this is a specialist field and outside the scope of our inspection. - Contact our official water safety partner the RLSS (Royal Life Saving Society) at www.rlss.org.uk and / or ensure that the appropriate risk assessment is in place

It is recommended that Adult Outdoor Fitness equipment is installed a minimum of 25m away from a childrens playground or separated and screened to discourage access by younger children - Monitor use and review risk assessment regularly

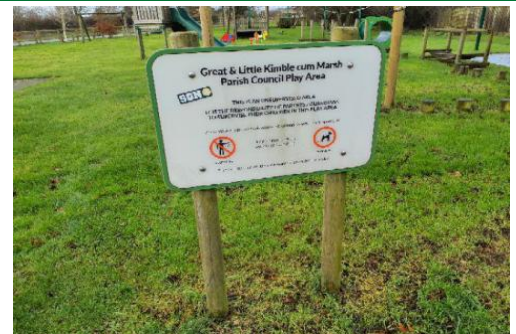
There is some strimmer / machinery damage apparent on the posts, this can penetrate the preservative applied to the timber and accelerate the rotting process - Monitor for any deterioration (rot) and replace as required

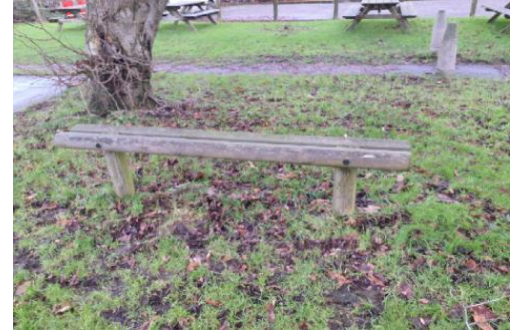
There are areas or parts of the timber on the structure that have rotted - Replace all affected timbers

There is some strimmer / machinery damage apparent on the posts, this can penetrate the preservative applied to the timber and accelerate the rotting process - Monitor for any deterioration (rot) and replace as required

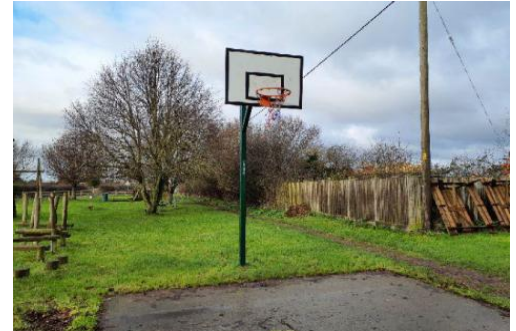
The net is damaged and requires removal / replacement - Replace

There are trip hazards at the edges of the surface - Remove trip hazard

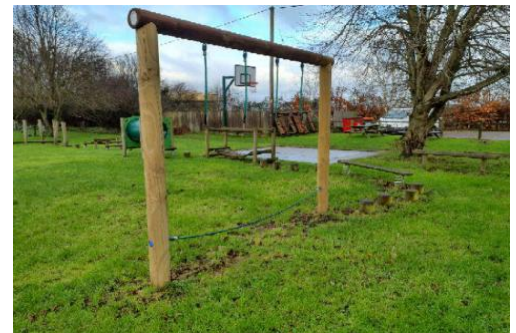
There are areas or parts of the timber on the structure that have rotted - Replace all affected timbers

There is some strimmer / machinery damage apparent on the posts, this can penetrate the preservative applied to the timber and accelerate the rotting process - Monitor for any deterioration (rot) and replace as required

There are areas or parts of the timber on the bridge that have rotted - Replace all affected timbers

There is/are bolt cap covers missing or damaged on the item - Replace missing or damaged bolt cap covers

There are areas or parts of the timber on the log weave that have rotted - Replace all affected timbers

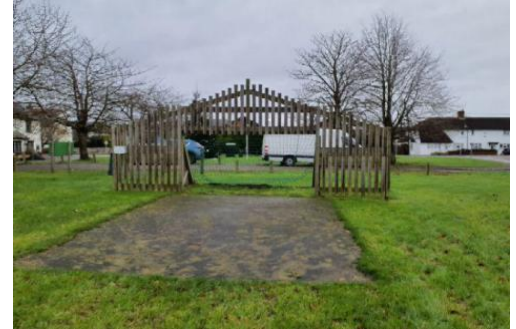
There are grass cuttings on the surface - Clear and maintain

There is algae, silt or moss growth on the surface resulting in slippery conditions - Clean and treat appropriately

There is some strimmer / machinery damage apparent on the posts, this can penetrate the preservative applied to the timber and accelerate the rotting process - Monitor for any deterioration (rot) and replace as required

There are areas or parts of the timber on the structure that have rotted - Replace all affected timbers

There are trip hazards at the edges of the surface - Remove trip hazard

The concrete edging is damaged - Monitor for any further deterioration and repair or replace as required

There is/are bolt cap covers missing or damaged on the item - Replace missing or damaged bolt cap covers

There is/are finger entrapments in the goal frame and the item fails to meet the requirements of BS EN 15312 Clause 4.4.2.2 Entrapment of fingers - Monitor - No action given the risk assessment

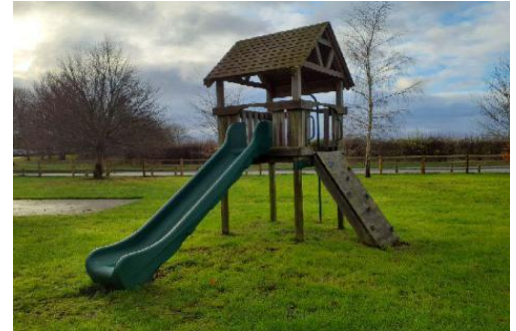
There is some evidence of rot in the timber - Monitor for any further deterioration and replace as required

There is some strimmer / machinery damage apparent on the posts, this can penetrate the preservative applied to the timber and accelerate the rotting process - Monitor for any deterioration (rot) and replace as required

The paintwork on this item has been damaged or worn exposing the metal underneath which is rusting / corroding - Treat affected areas and repaint

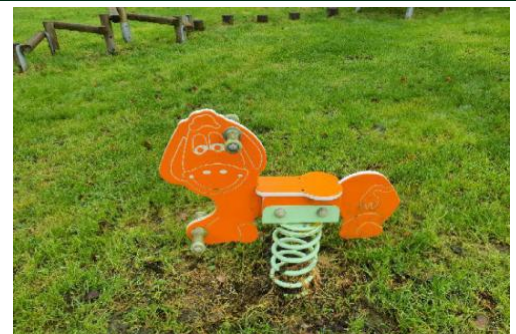
The Handgrips/Footrests rotate and may cause an unexpected movement for the user - Secure Handgrips/Footrests to prevent rotation.

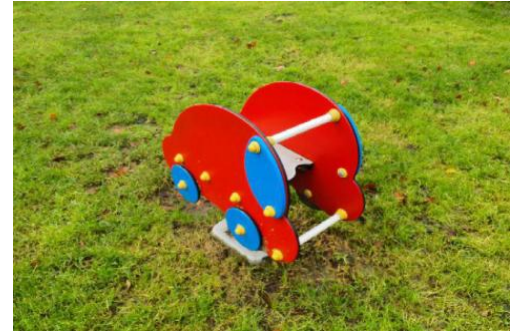
The surface has eroded in some areas and may be slippery in wet conditions - Reinstate the surface

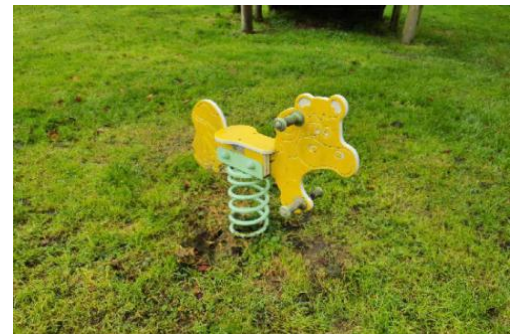
The Handgrips/Footrests rotate and may cause an unexpected movement for the user - Secure Handgrips/Footrests to prevent rotation.

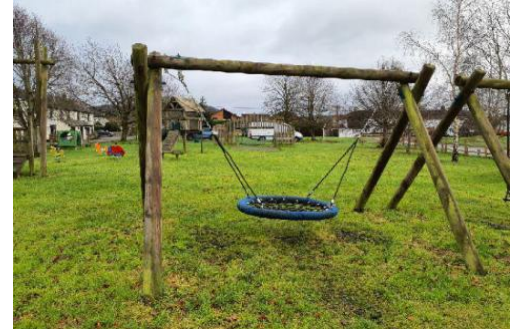
The ropes/nets are worn/damaged in places - Monitor for any further deterioration and repair or replace as required

There is some notable evidence of chain wear - Monitor for any further deterioration and replace when 40% worn

A number of fixing(s) have worked loose on the suspension brackets - Secure all loose fixings

The bush / bushes is / are showing signs of wear - Monitor for any further deterioration and replace as required

The timber has a number of splits/shakes or air cracks and this may affect the stability or allow water ingress which will accelerate the rotting process - Monitor to ensure the splits do not cross through fixing points of the structure and/or cause any instability

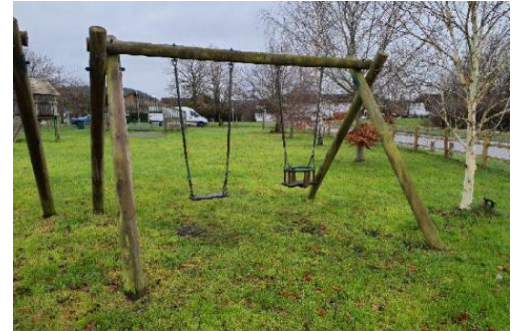
The chain openings are in excess of the 8.6mm as recommended by BS EN 1176 - Monitor - No action given the risk assessment

The bush / bushes is / are worn or missing - Replace worn or missing bushes

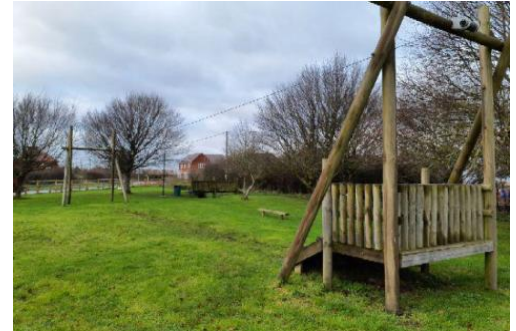
We have completed a visual inspection of the suspension links, cable and fixing points from ground level, however it is not possible to fully inspect these areas without either hiring equipment to gain access or removing the cable and suspension and inspecting at ground level. We recommend that the main cable and fixing security is thoroughly inspected at least in accordance with the manufacturers recommendations to check for wear, damage, security or internal rusting; this will help to ensure the continued safe use of the equipment - Inspect in accordance with the manufacturers recommendations

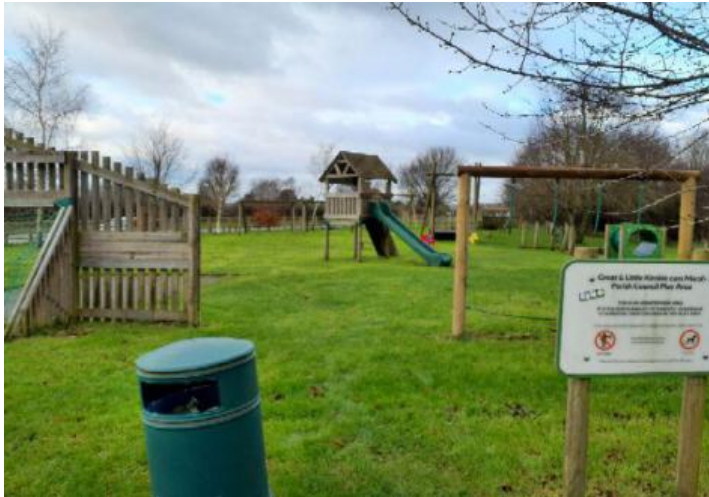
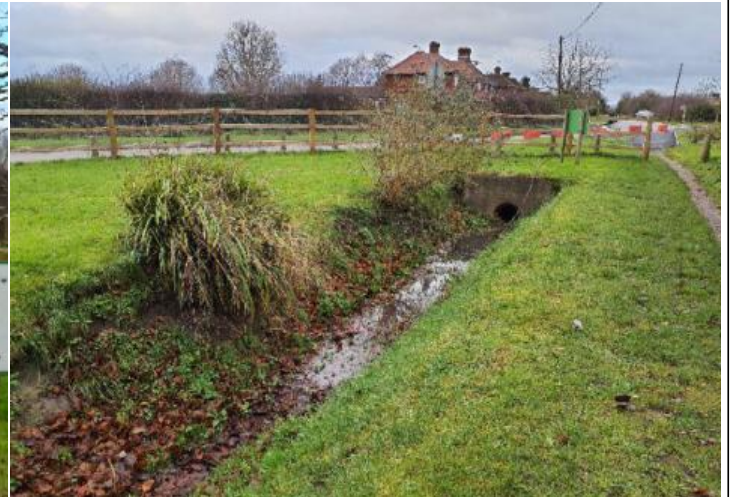
Finding: NOTE - There is a body of water or a water basin in close proximity to the playground. Risk assessment of this is a specialist field and outside the scope of our inspection.

Action: Contact our official water safety partner the RLSS (Royal Life Saving Society) at www.rlss.org.uk and / or ensure that the appropriate risk assessment is in place

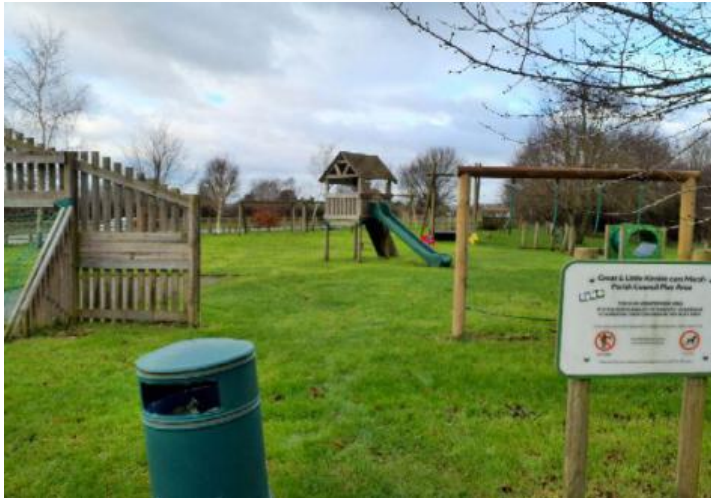
Finding: It is recommended that Adult Outdoor Fitness equipment is installed a minimum of 25m away from a childrens playground or separated and screened to discourage access by younger children

Action: Monitor use and review risk assessment regularly

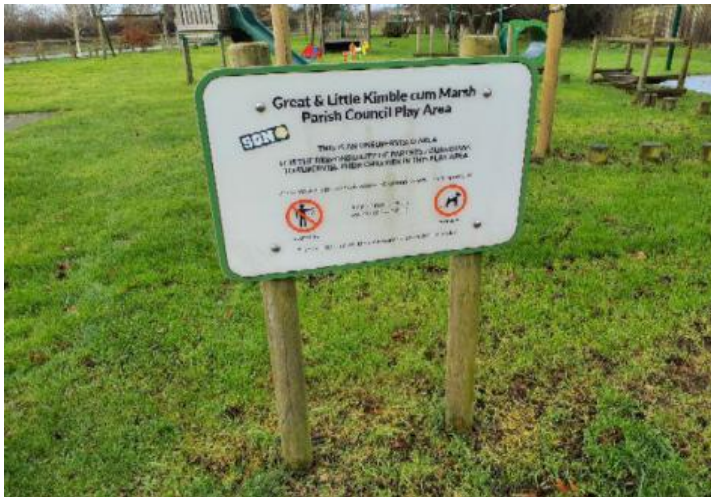
Finding: There is some strimmer / machinery damage apparent on the posts, this can penetrate the preservative applied to the timber and accelerate the rotting process

Action: Monitor for any deterioration (rot) and replace as required

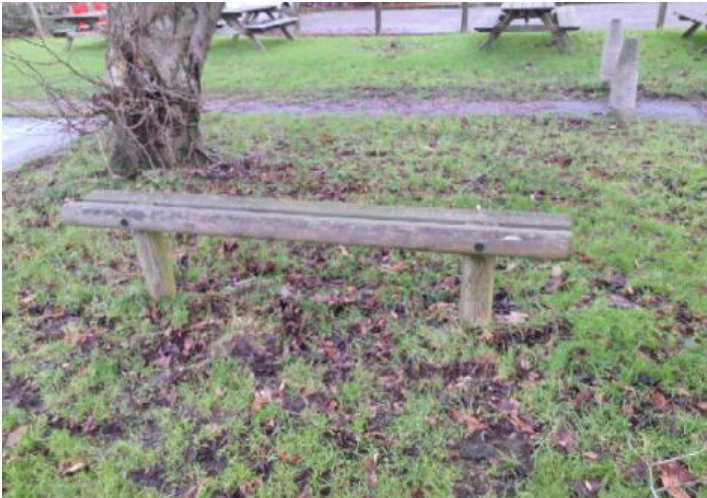
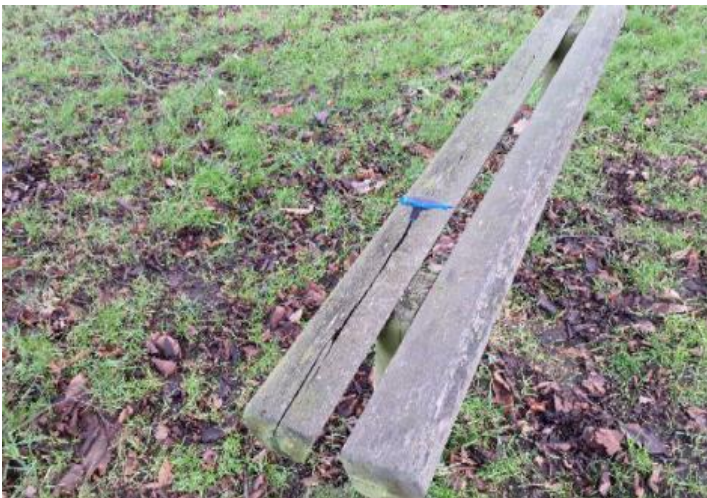
Finding: There are areas or parts of the timber on the structure that have rotted

Action: Replace all affected timbers

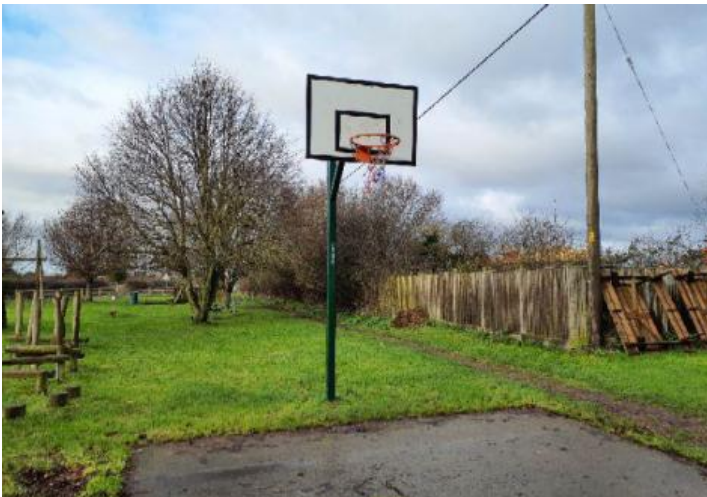
Finding: The net is damaged and requires removal / replacement

Action: Replace

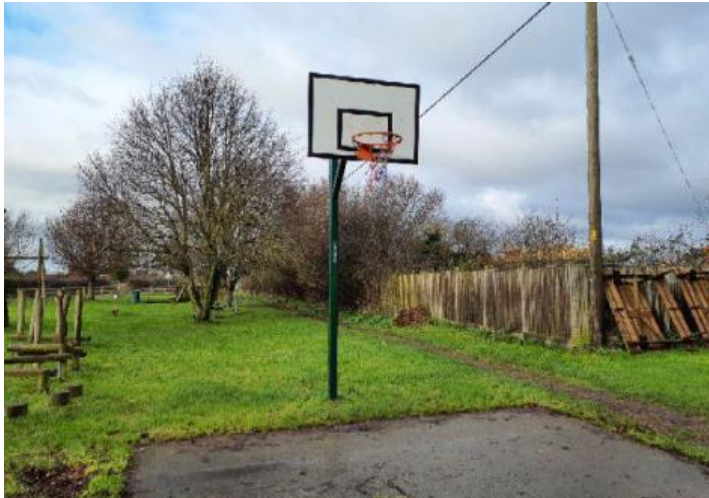
Finding: There are trip hazards at the edges of the surface **Action:** Remove trip hazard

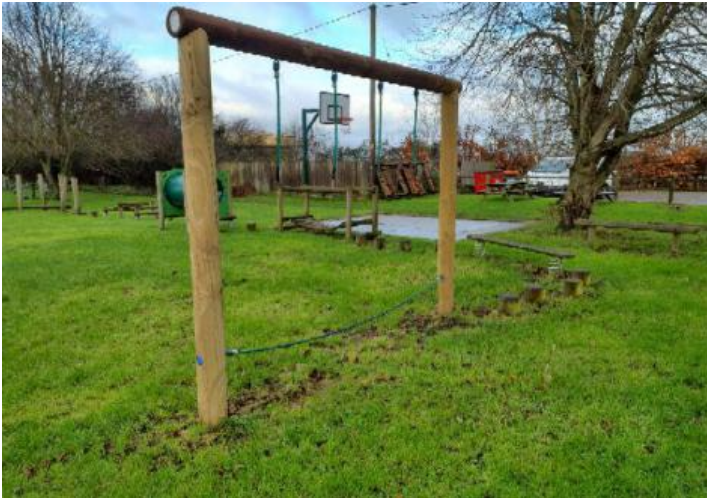
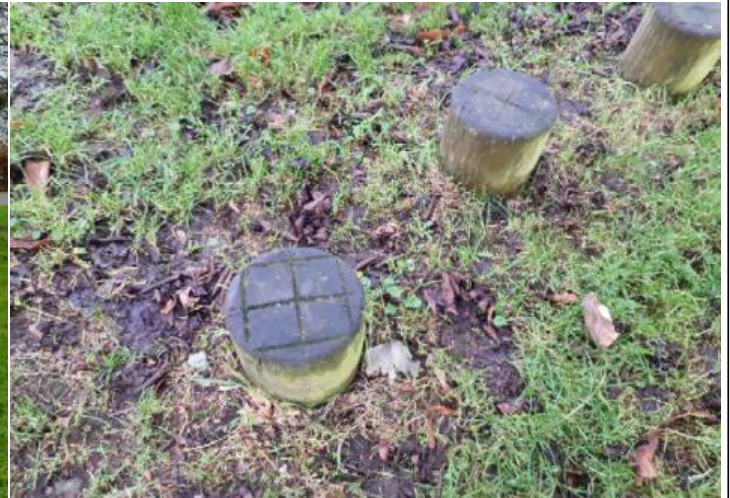
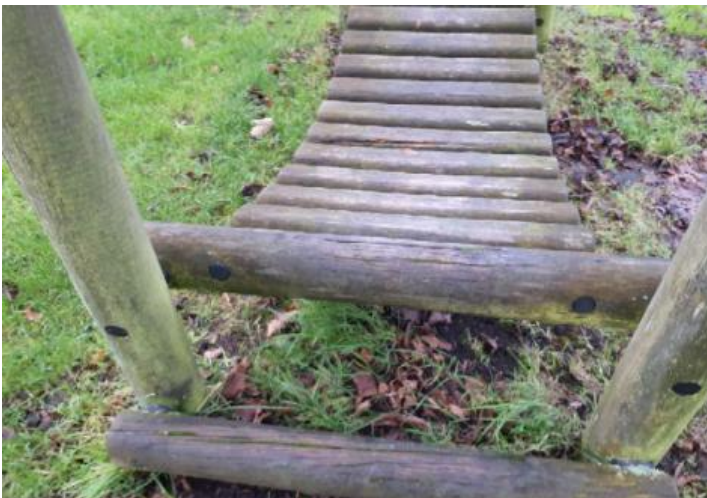
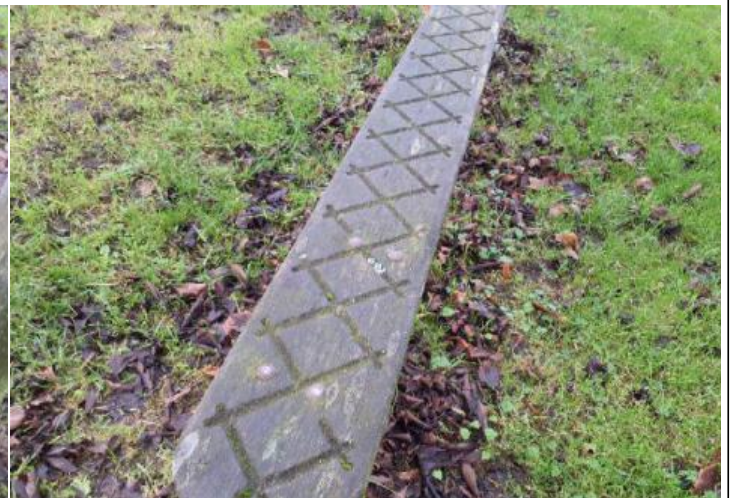
Finding: There is algae or moss on the surface of the equipment

Action: Clean and treat appropriately

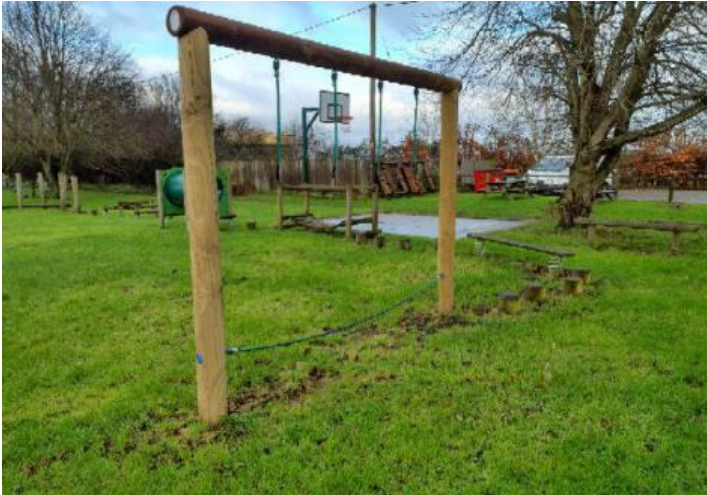
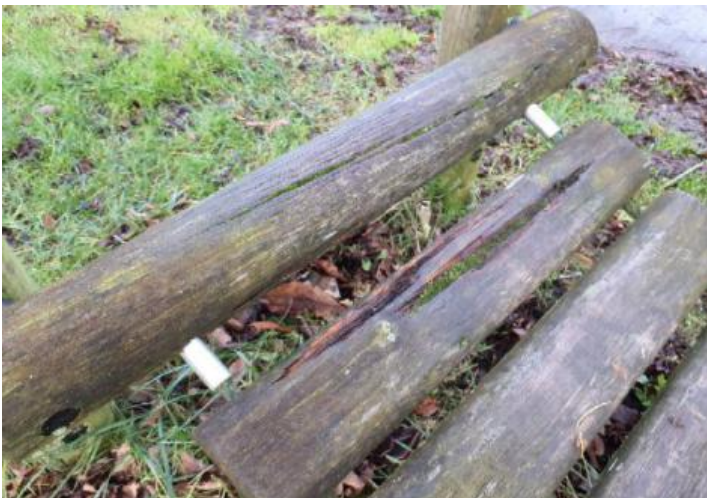
Finding: There are areas or parts of the timber on the bridge that have rotted

Action: Replace all affected timbers

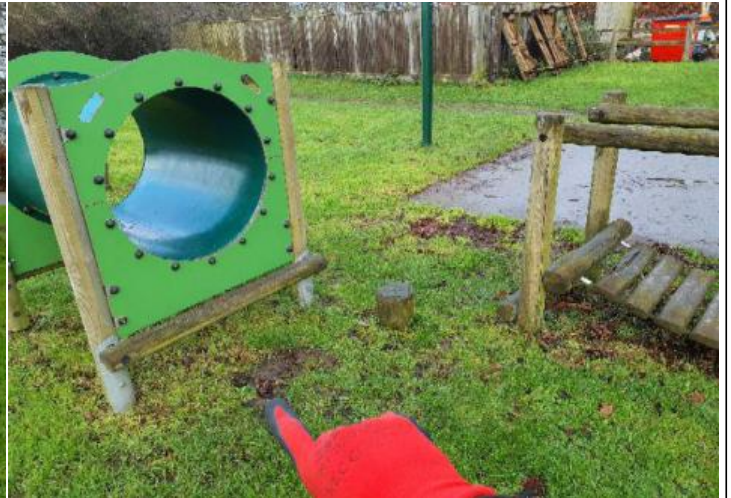
Finding: The projecting tree root forms an projecting obstacle / hard object within the falling space of the equipment, in contravention of the requirements of BS EN 1176 Part 1

Action: Reinststate the surface to cover the tree roots

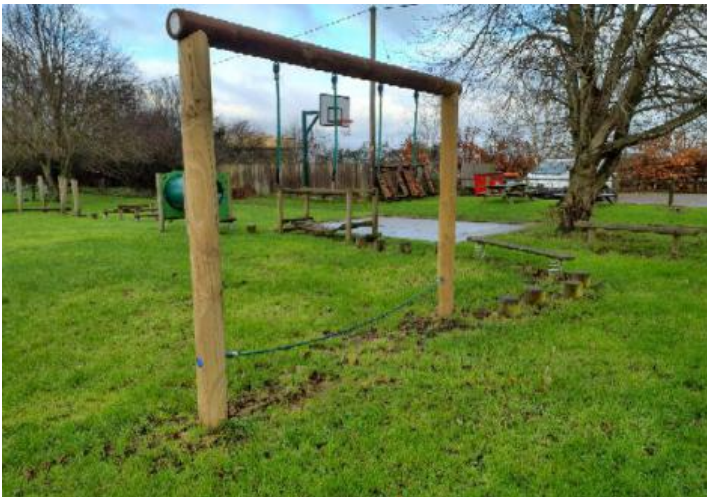
Finding: There is/are bolt cap covers missing or damaged on the item

Action: Replace missing or damaged bolt cap covers

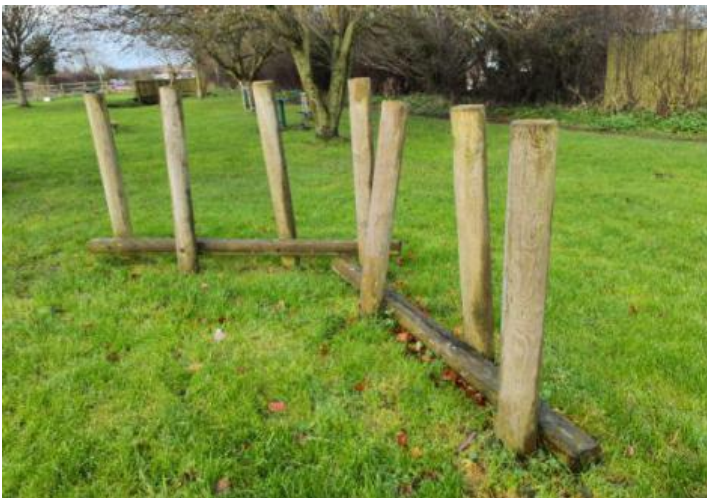
Finding: There are areas or parts of the timber on the log weave that have rotted

Action: Replace all affected timbers

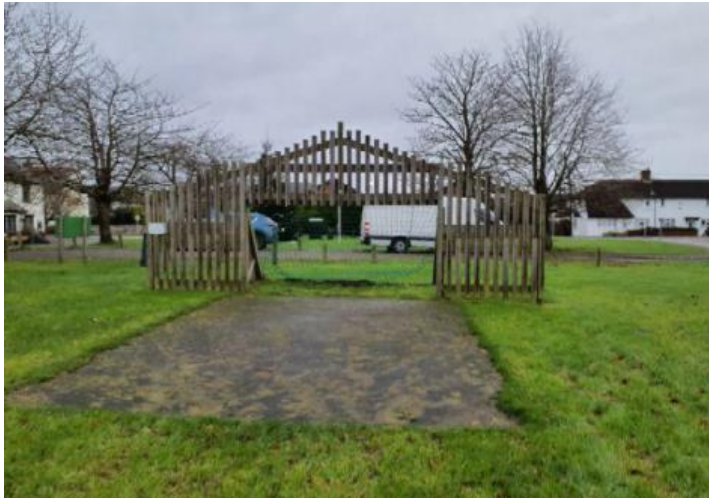
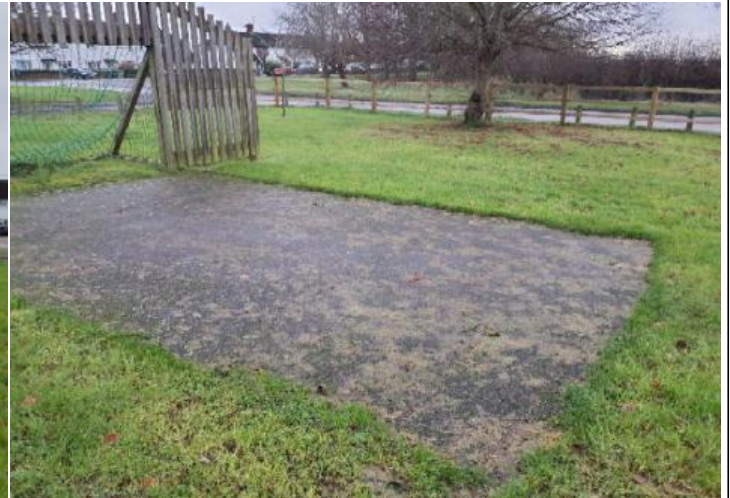
Finding: There are grass cuttings on the surface

Action: Clear and maintain

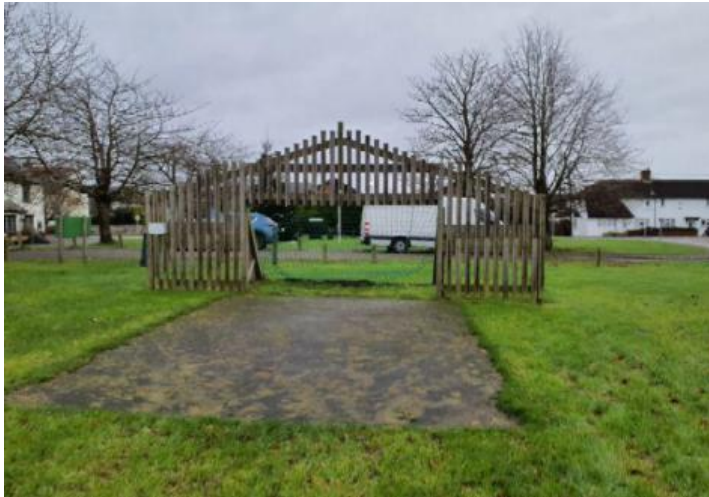
Finding: There are trip hazards at the edges of the surface

Action: Remove trip hazard

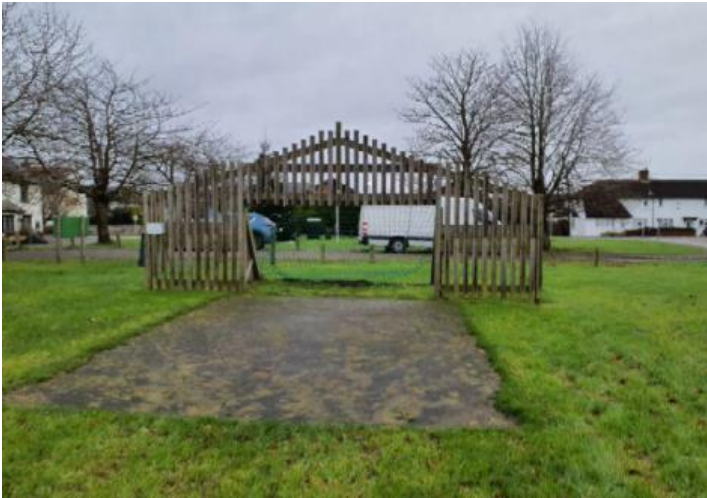
Finding: There is algae, silt or moss growth on the surface resulting in slippery conditions

Action: Clean and treat appropriately

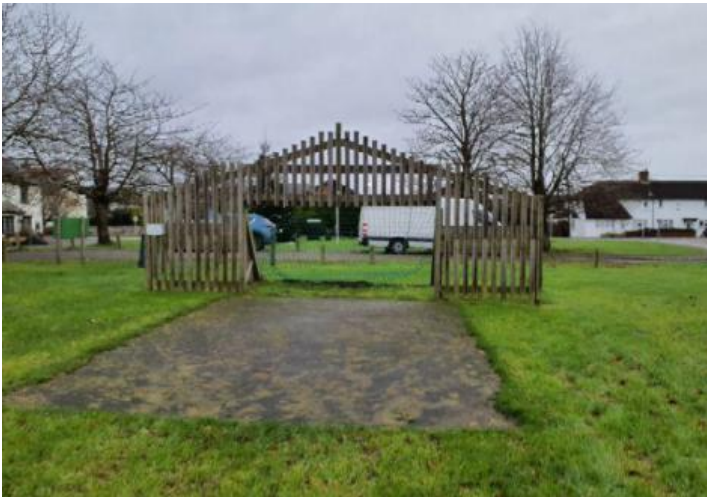
Item: Multi Use Games Area - Goal End
Manufacturer: Sovereign Leisure

Finding: The concrete edging is damaged

Action: Monitor for any further deterioration and repair or replace as required

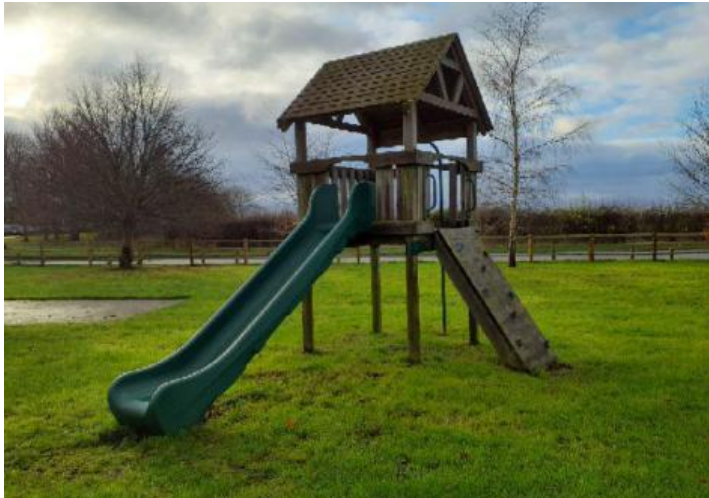
Item: Activity Equipment - Multi Play (Junior)
Manufacturer: Not Identified

Finding: There is some evidence of rot in the timber

Action: Monitor for any further deterioration and replace as required

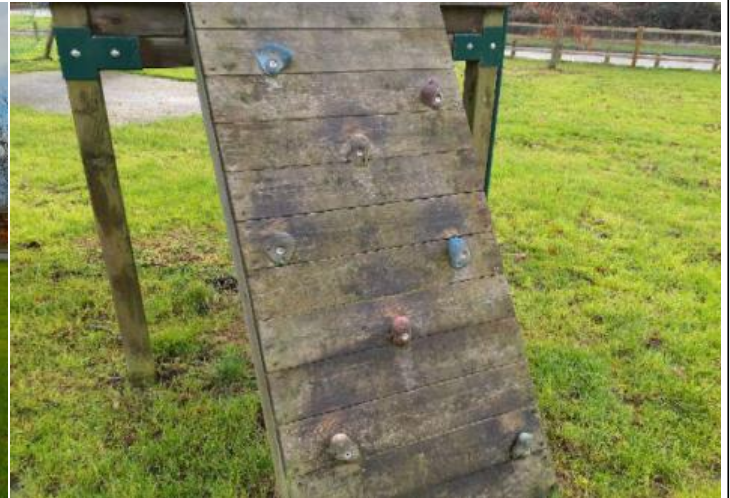
Item: Activity Equipment - Multi Play (Junior)
Manufacturer: Not Identified

Finding: There is algae or moss on the surface of the equipment

Action: Clean and treat appropriately

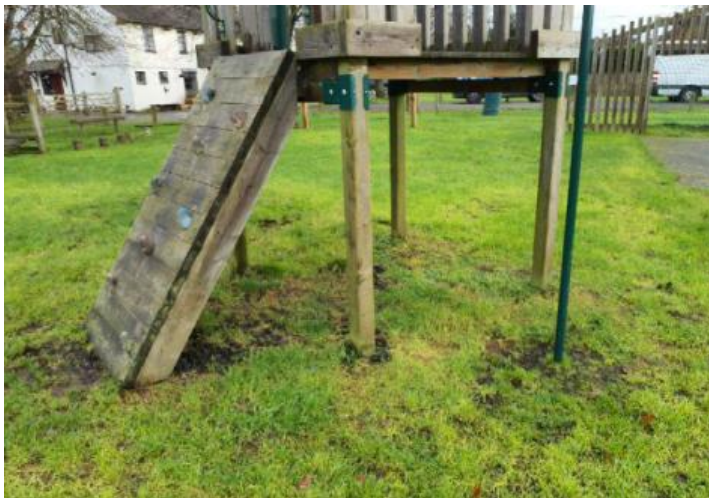
Item: Activity Equipment - Multi Play (Junior)
Manufacturer: Not Identified

Finding: There is some strimmer / machinery damage apparent on the posts, this can penetrate the preservative applied to the timber and accelerate the rotting process

Action: Monitor for any deterioration (rot) and replace as required

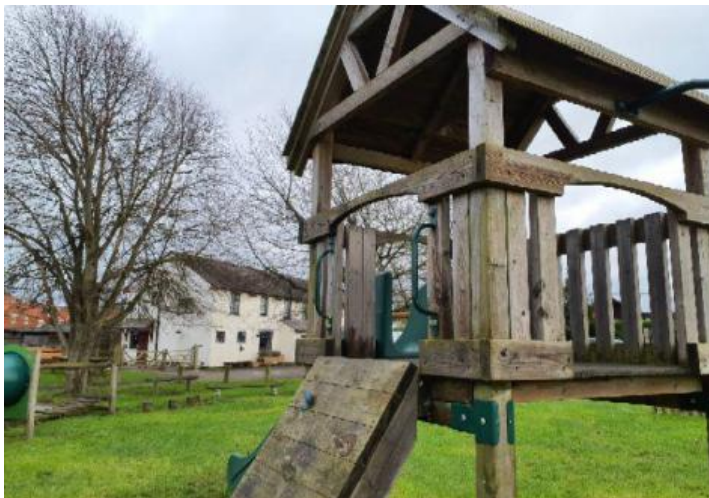
Item: Activity Equipment - Multi Play (Junior)
Manufacturer: Not Identified

Finding: The paintwork on this item has been damaged or worn exposing the metal underneath which is rusting / corroding

Action: Treat affected areas and repaint

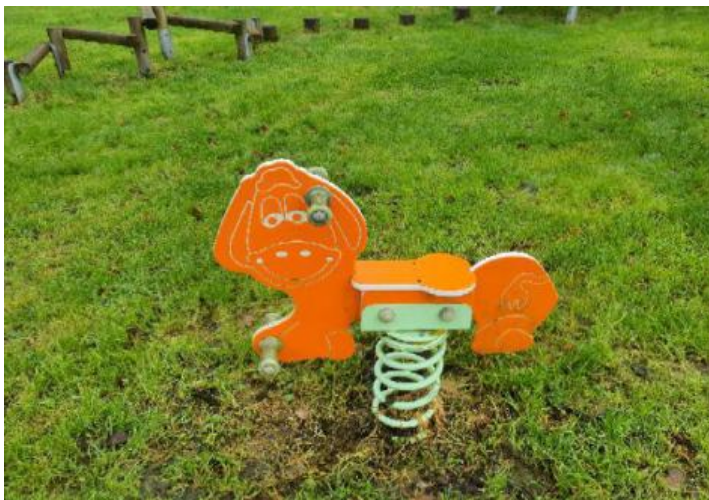
Item: Rocking Equipment - Spring Dog
Manufacturer: KBT

Finding: The Handgrips/Footrests rotate and may cause an unexpected movement for the user

Action: Secure Handgrips/Footrests to prevent rotation.

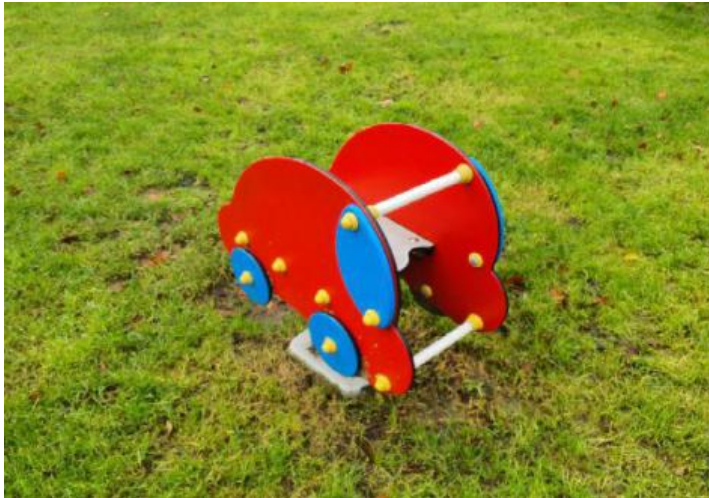
Item: Rocking Equipment - Spring Car
Manufacturer: KBT

Finding: The surface has eroded in some areas and may be slippery in wet conditions
Action: Reinstate the surface

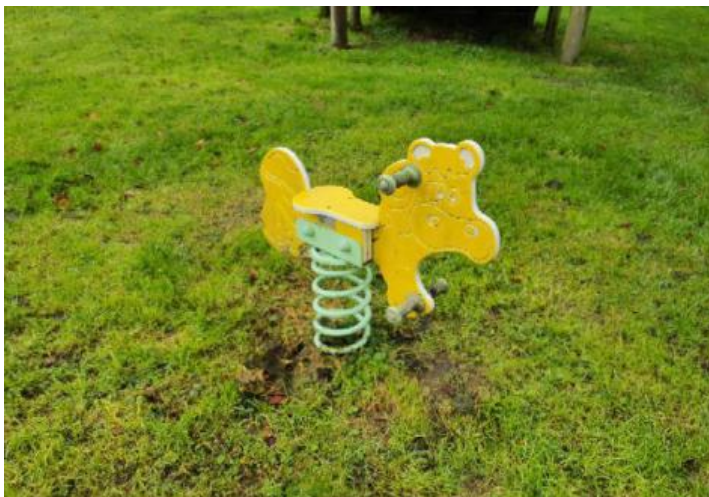
Item: Rocking Equipment - Spring Cow
Manufacturer: KBT

Finding: The Handgrips/Footrests rotate and may cause an unexpected movement for the user
Action: Secure Handgrips/Footrests to prevent rotation.

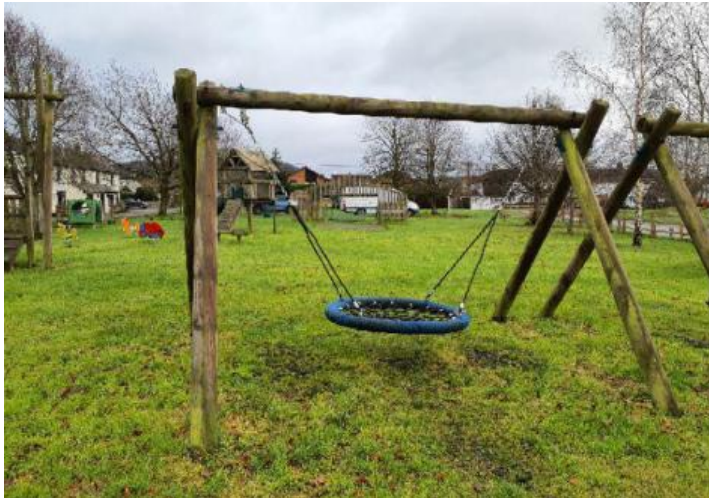
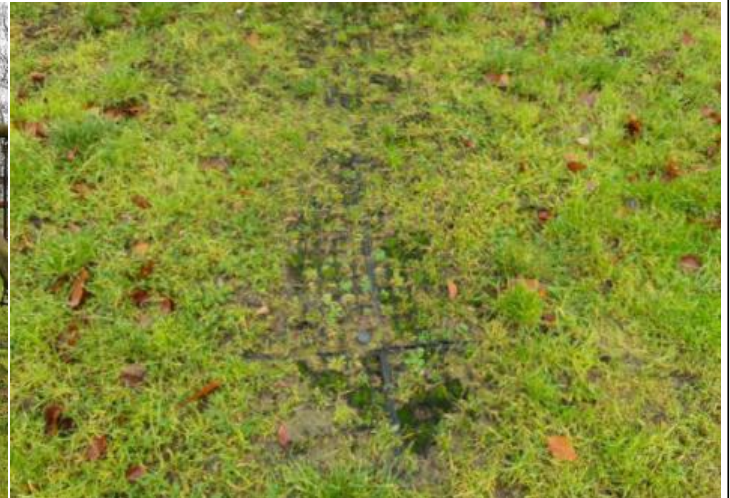
Item: Swings - Basket Swing - Type 1
Manufacturer: Not Identified

Finding: Fixing Pins have been installed in the impact areas of the grass mats
Action: Remove pins from impact areas

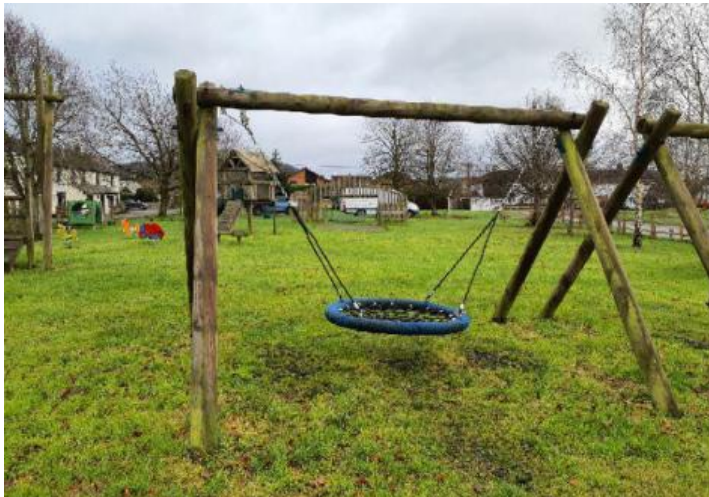
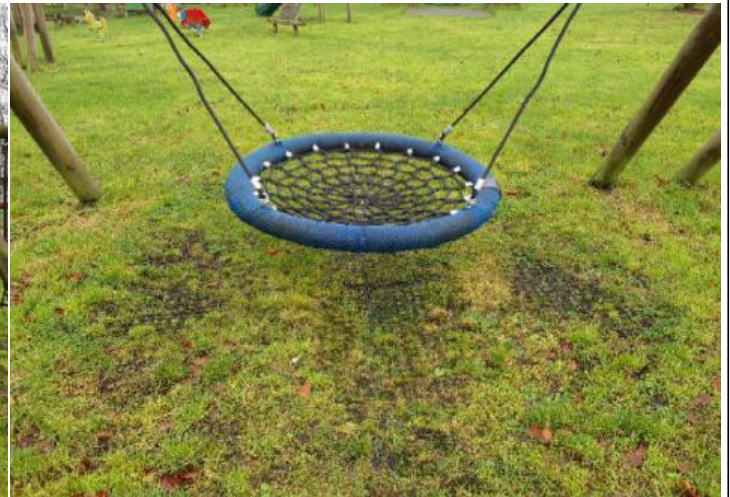
Item: Swings - Basket Swing - Type 1
Manufacturer: Not Identified

Finding: The seat clearance from finished surface level to the underside of the seat is too low and does not meet the requirements of BS EN 1176 Part 2 (400mm minimum clearance required from rigid part of seat in most onerous position)
Action: Adjust seat clearance

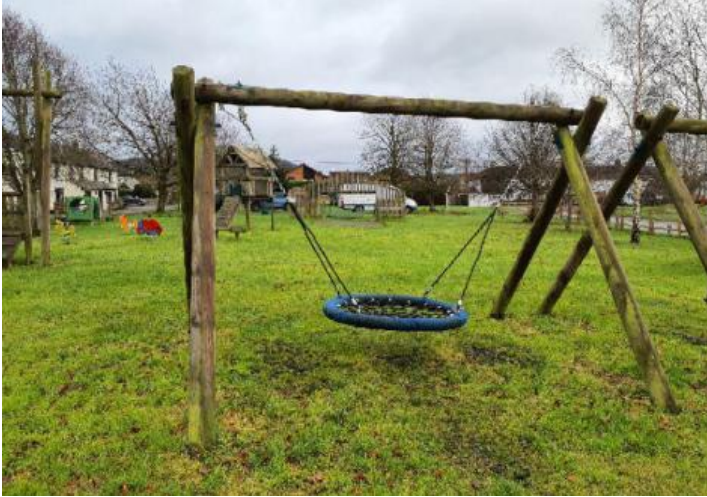
Item: Swings - Basket Swing - Type 1
Manufacturer: Not Identified

Finding: There is some notable evidence of chain wear

Action: Monitor for any further deterioration and replace when 40% worn

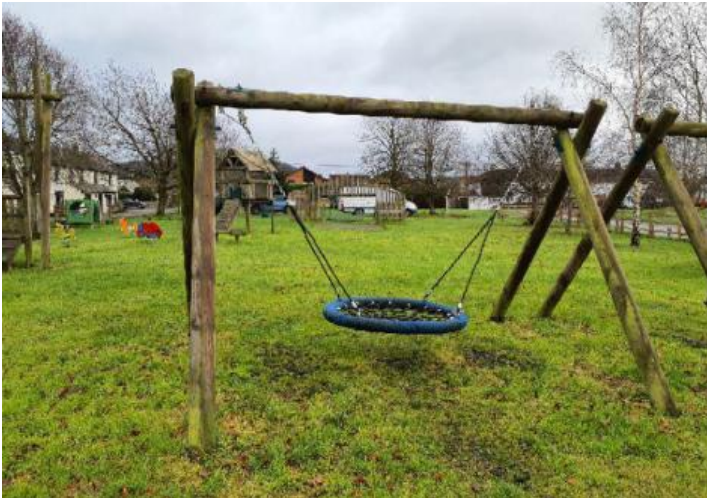
Item: Swings - Basket Swing - Type 1
Manufacturer: Not Identified

Finding: A number of fixing(s) have worked loose on the suspension brackets

Action: Secure all loose fixings

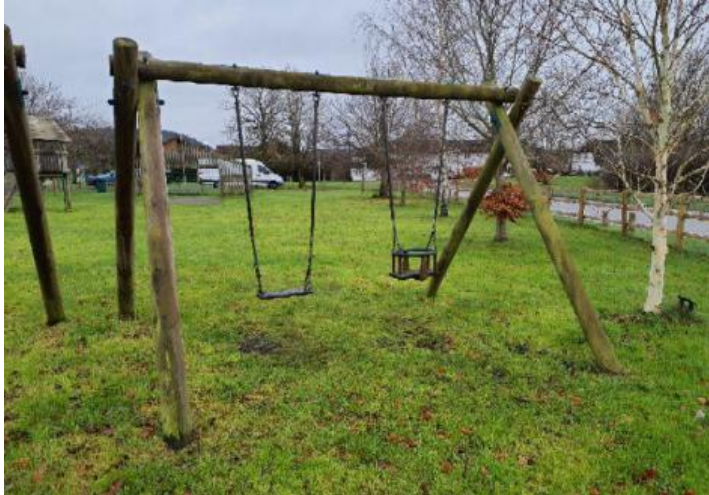
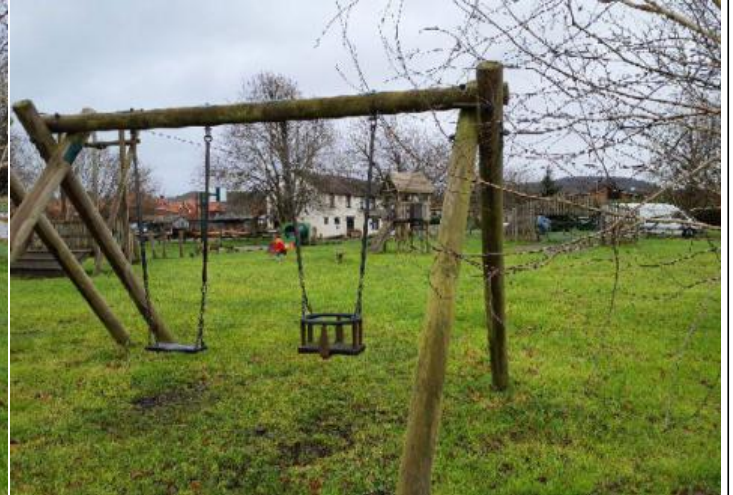
Finding: The tree canopy overhangs the equipment and is less than 2.0m away

Action: Lift tree canopy to ensure a minimum clearance of 2.0m from the equipment

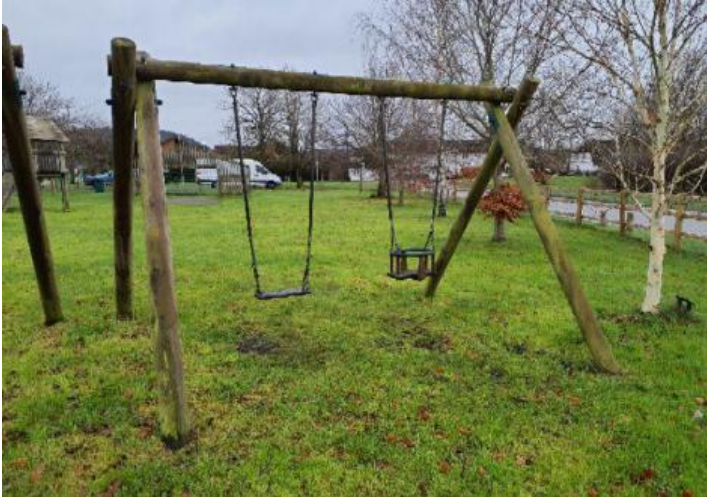
Finding: The chain openings are in excess of the 8.6mm as recommended by BS EN 1176 **Action:** Monitor - No action given the risk assessment

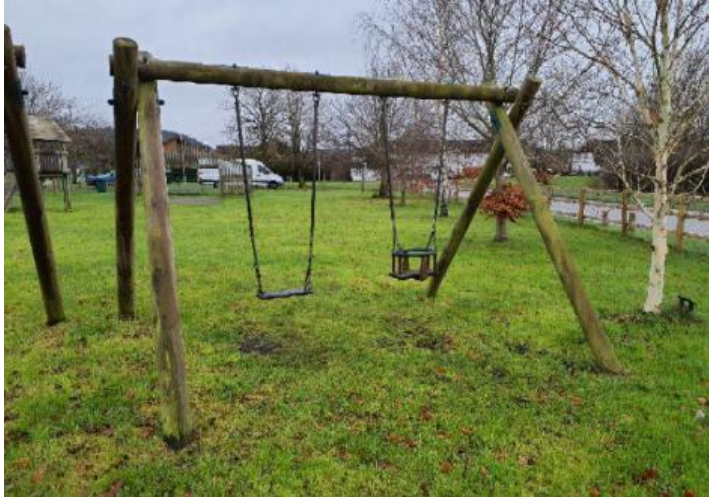
Finding: The connecting links are in excess of 8.6mm and less than 12mm and fail the requirements of BS EN 1176 Part 1; clause 4.2.13, Chains

Action: Monitor - No action given the risk assessment

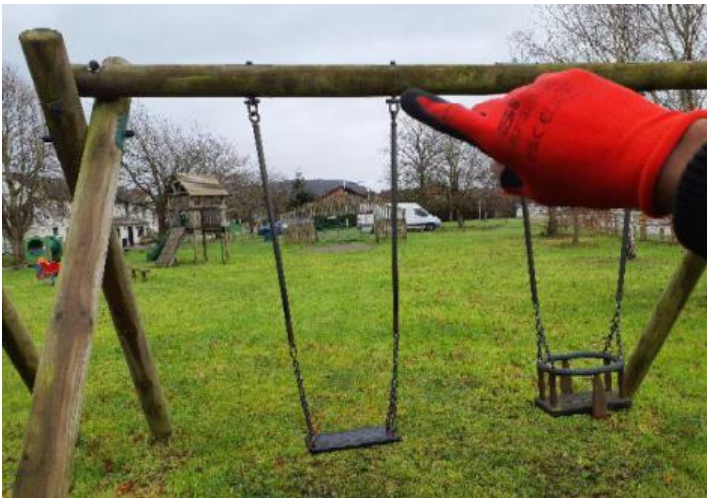
Item: Swings - 1 Bay Mixed Seat, 1 Cradle, 1 Flat
Manufacturer: Not Identified

Finding: The bush / bushes is / are worn or missing

Action: Replace worn or missing bushes

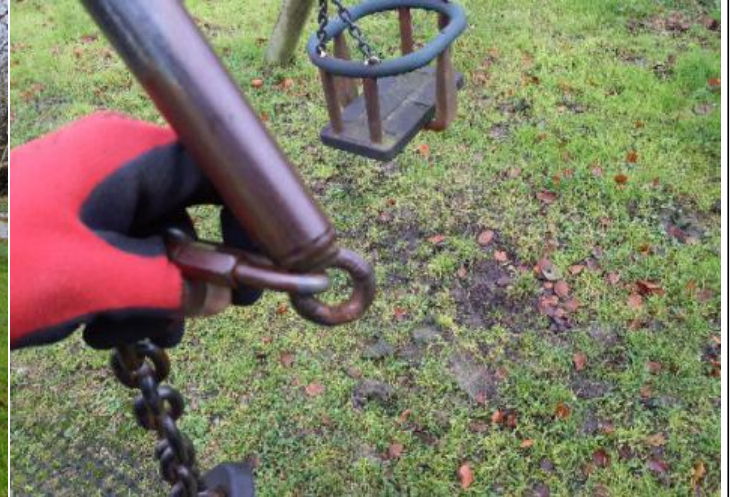
Finding: There is some notable evidence of connecting link wear

Action: Monitor for any further deterioration and replace when 40% worn

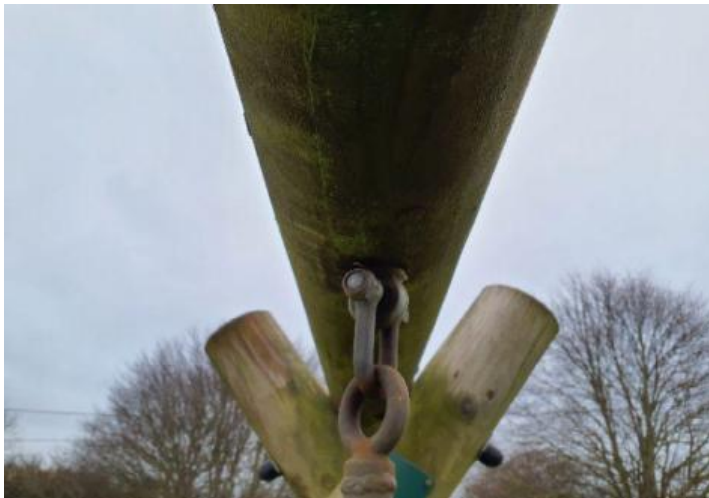
Finding: The suspension member shackle is not aligned correctly with the direction of travel creating accelerated wear

Action: Adjust the alignment of the suspension shackle

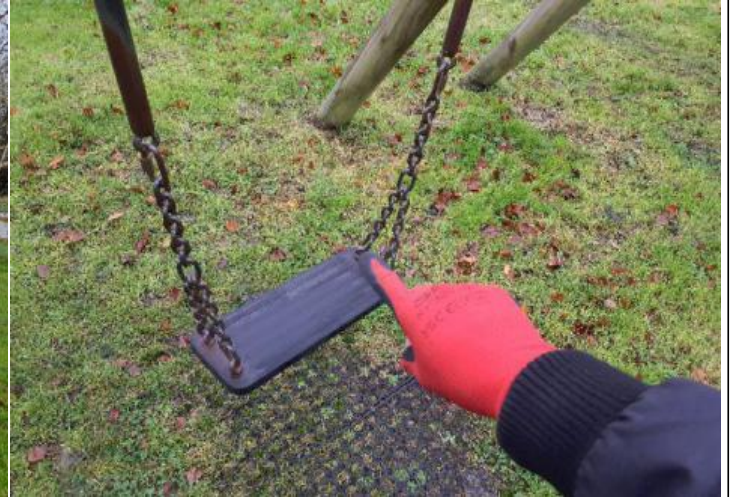
Finding: The swing seat connectors are loose

Action: Tighten to secure

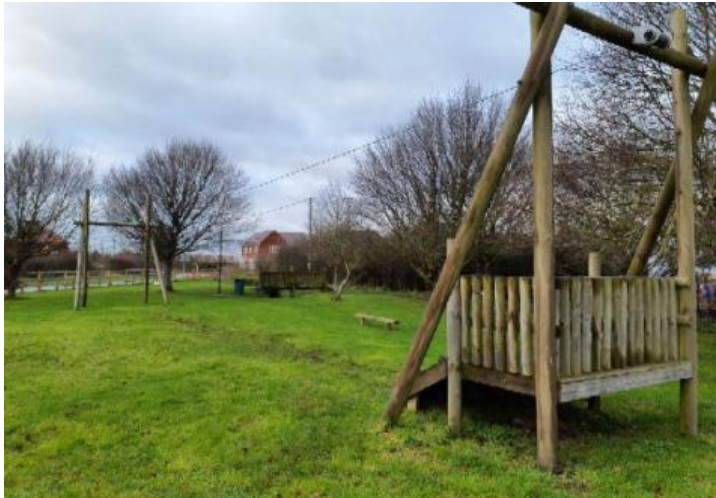
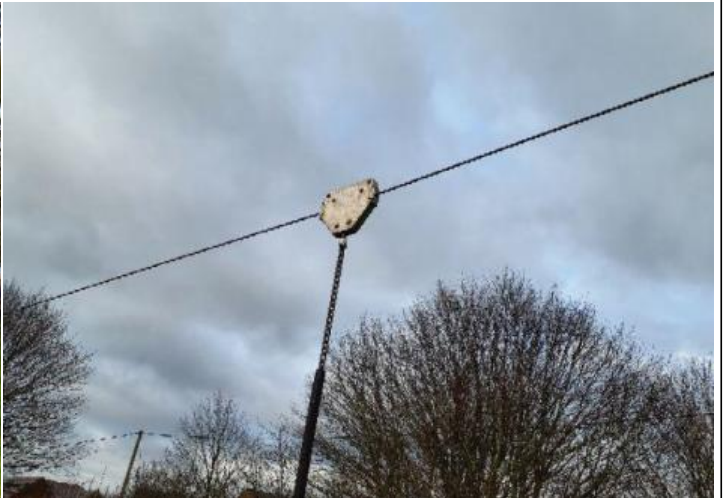
Item:	Other - Cable Runway	Risk Level:	N - Risk Assessment not Undertaken
Manufacturer:	Not Identified	Surface:	Grass Matrix Tiles

Finding: We have completed a visual inspection of the suspension links, cable and fixing points from ground level, however it is not possible to fully inspect these areas without either hiring equipment to gain access or removing the cable and suspension and inspecting at ground level. We recommend that the main cable and fixing security is thoroughly inspected at least in accordance with the manufacturers recommendations to check for wear, damage, security or internal rusting; this will help to ensure the continued safe use of the equipment

Action: Inspect in accordance with the manufacturers recommendations

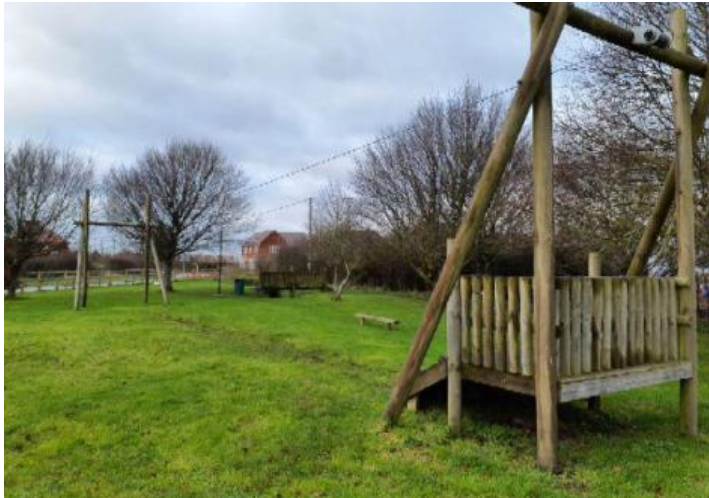
Item: Other - Cable Runway
Manufacturer: Not Identified

Finding: The seat connection cannot be inspected without dismantling the seat

Action: Dismantle the seat to inspect the seat connection for wear

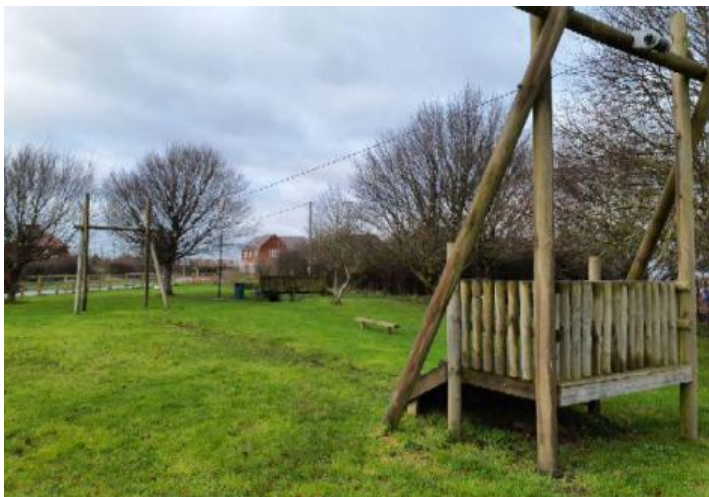
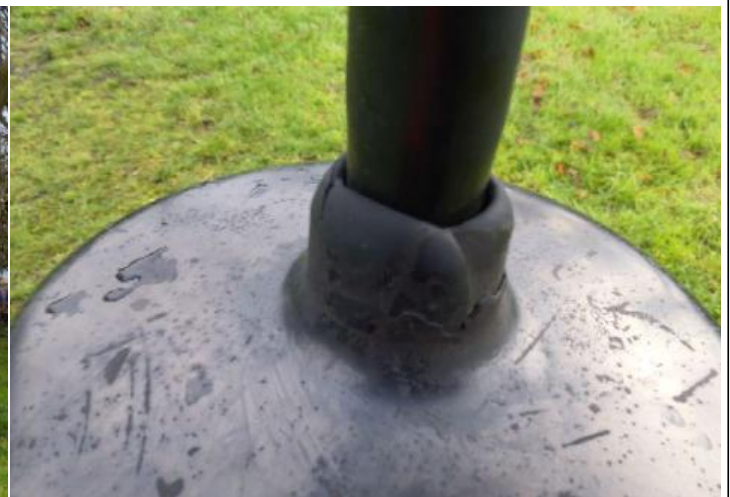
Item: Other - Cable Runway
Manufacturer: Not Identified

Finding: The cableway seat has been damaged

Action: Monitor for any further deterioration and replace as required

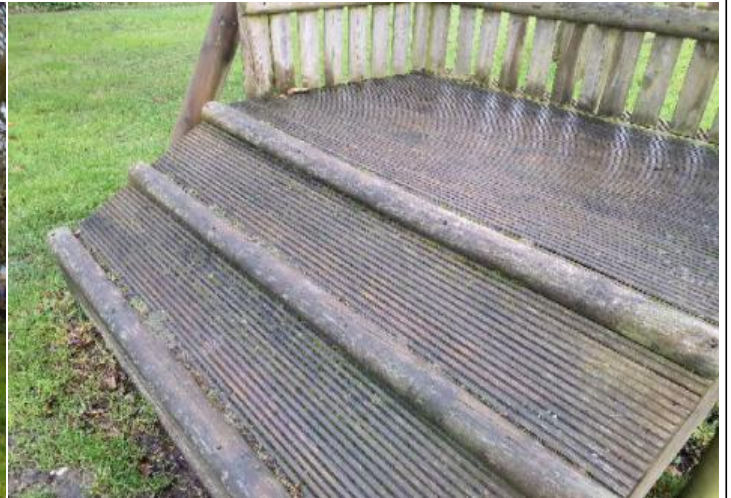
Item: Other - Cable Runway
Manufacturer: Not Identified

Finding: There is algae or moss on the surface of the equipment

Action: Clean and treat appropriately
