the **play inspection** company

Annual Inspection

Kimble Parish Council

Kimble Green Play Area

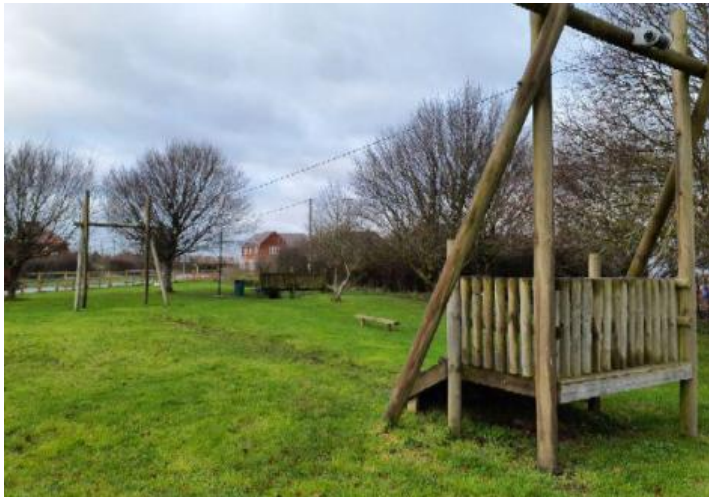
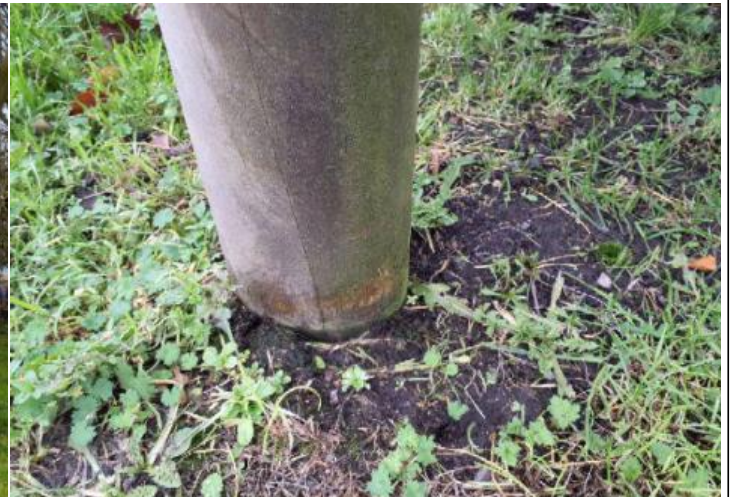
Item: Other - Cable Runway
Manufacturer: Not Identified

Finding: There is some strimmer / machinery damage apparent on the posts, this can penetrate the preservative applied to the timber and accelerate the rotting process

Action: Monitor for any deterioration (rot) and replace as required

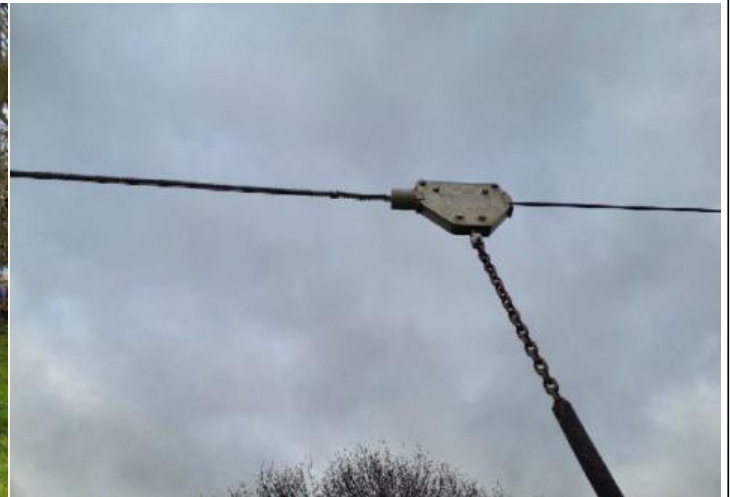
Item: Other - Cable Runway
Manufacturer: Not Identified

Finding: The dampening spring or tyre is damaged or broken on the item

Action: Replace spring or tyre

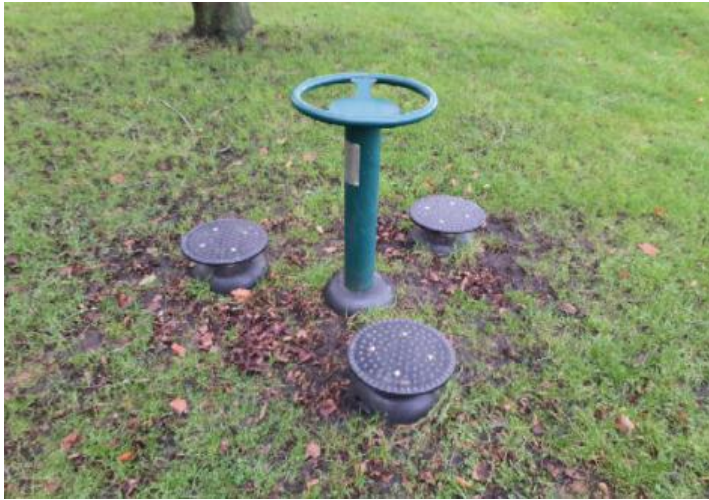
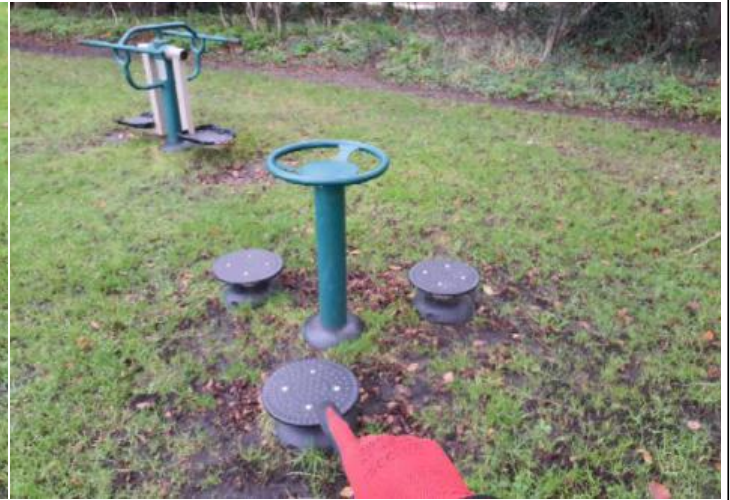
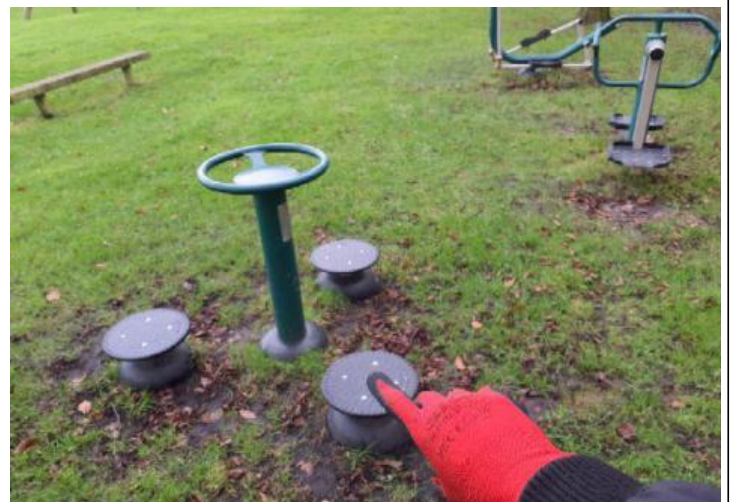
Item: Outdoor Fitness Equipment - Hip Twister
Manufacturer: Sunshine Gym

Finding: The deflection of the rotating user station exceeds the maximum 105 degrees required by BS EN 16630

Action: Monitor - No action given the risk assessment

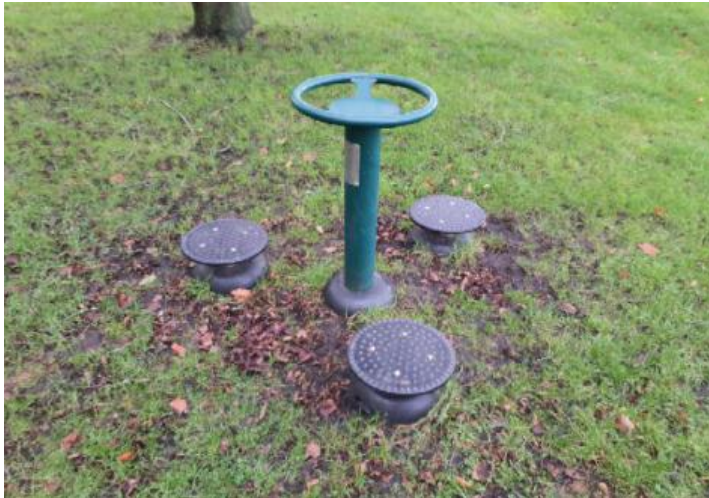
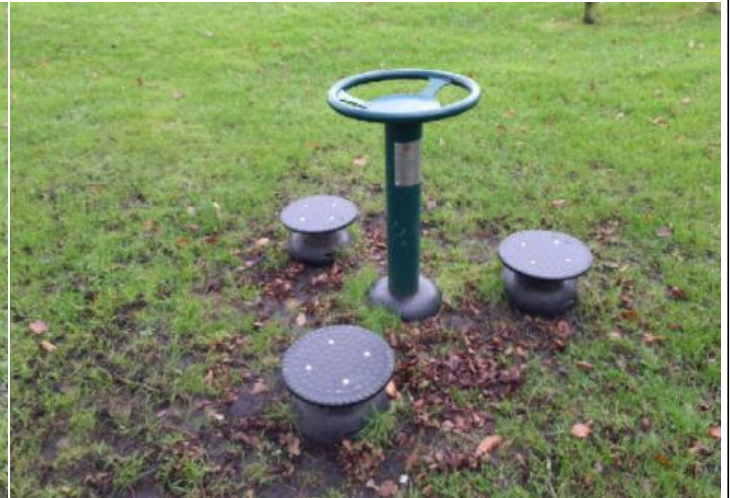
Item: Outdoor Fitness Equipment - Hip Twister
Manufacturer: Sunshine Gym

Finding: This item has been scaled down and is not covered by the scope of BS EN 16630 which specifically relates to equipment for users of 140cm and above. We have however used our knowledge of this standard to form the basis of our assessment as it is the closest applicable standard available

Action: Ensure there is a full and sufficient risk assessment in place covering the use of this product in this environment

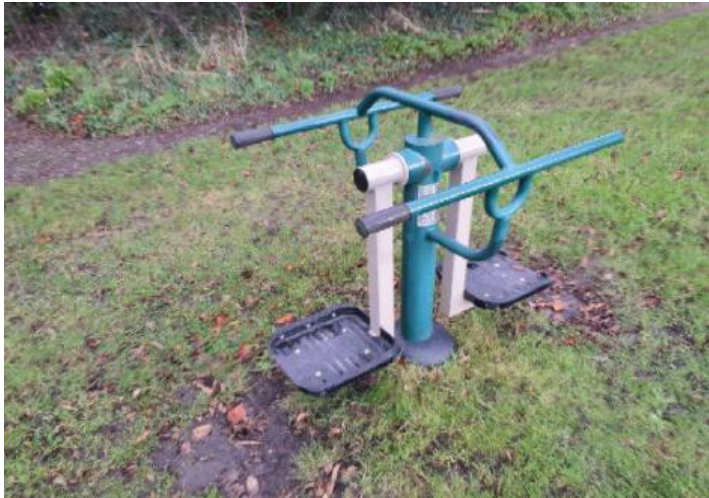
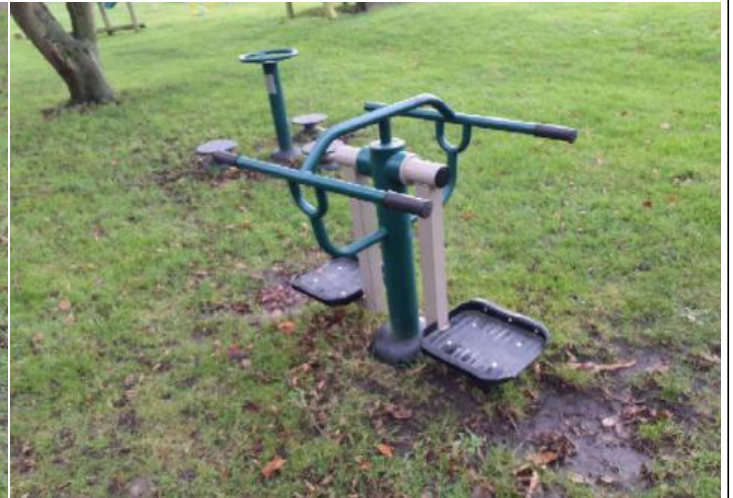
Item: Outdoor Fitness Equipment - Ski Stepper
Manufacturer: Sunshine Gym

Finding: This item has been scaled down and is not covered by the scope of BS EN 16630 which specifically relates to equipment for users of 140cm and above. We have however used our knowledge of this standard to form the basis of our assessment as it is the closest applicable standard available

Action: Ensure there is a full and sufficient risk assessment in place covering the use of this product in this environment

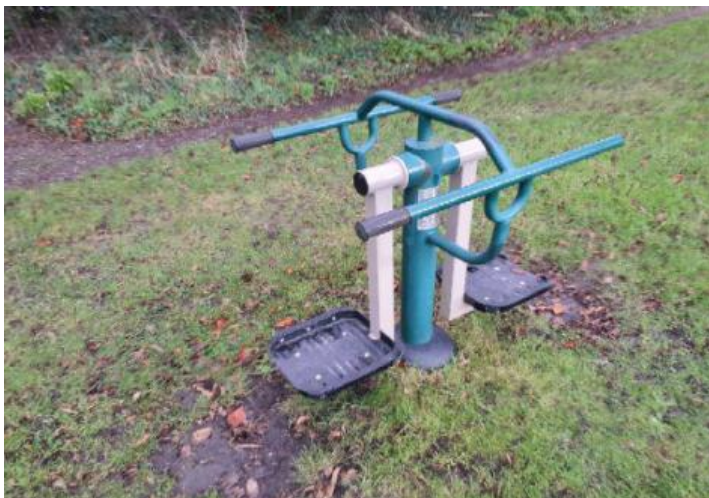
Item: Outdoor Fitness Equipment - Ski Stepper
Manufacturer: Sunshine Gym

Finding: The surface has eroded in some areas and may be slippery in wet conditions

Action: Reinstate the surface

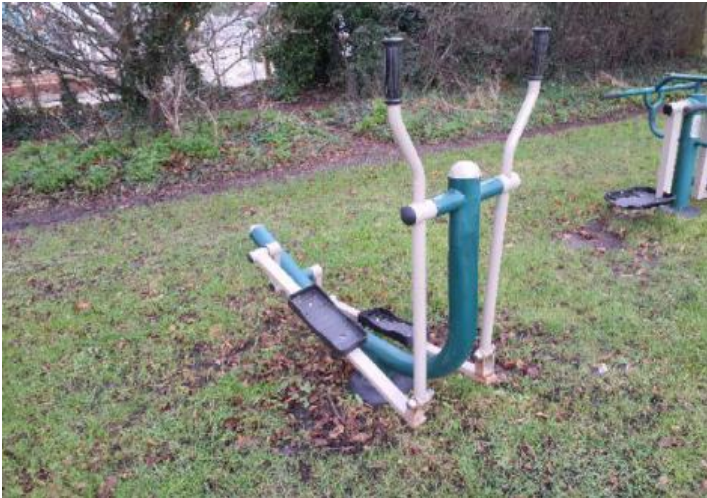
Item: Outdoor Fitness Equipment - Cross Trainer **Risk Level:** L - Low Risk
Manufacturer: Sunshine Gym **Surface:** Grass

Finding: The bearing is worn / damaged and the item is not operating correctly **Action:** Repair / replace

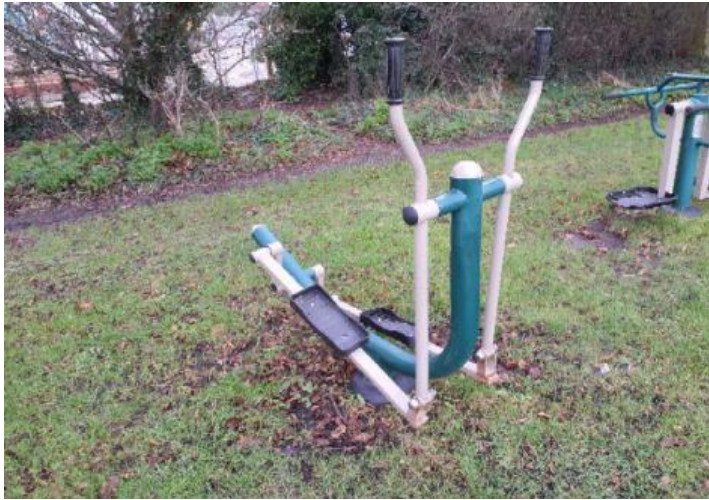
i 6 - Low Risk (Finding 5)

Item: Outdoor Fitness Equipment - Cross Trainer **Risk Level:** L - Low Risk
Manufacturer: Sunshine Gym **Surface:** Grass

Finding: A number of fixing(s) have worked loose

Action: Secure all loose fixings
